## Standard Building Inspection

### Summary Report

**Subject Property:** Ft. Lauderdale Station and Passenger Loading Platform

**Client:** FDOT

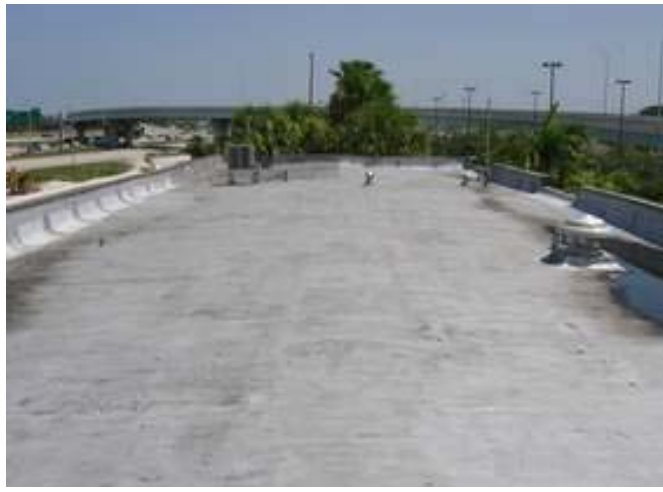
- The flat section of the roof over the Station Building appears to be in reasonably good condition and with proper maintenance could last five years or more.

The flat section of the roof over the Station Building appears to be in fair condition but in need of immediate repairs.

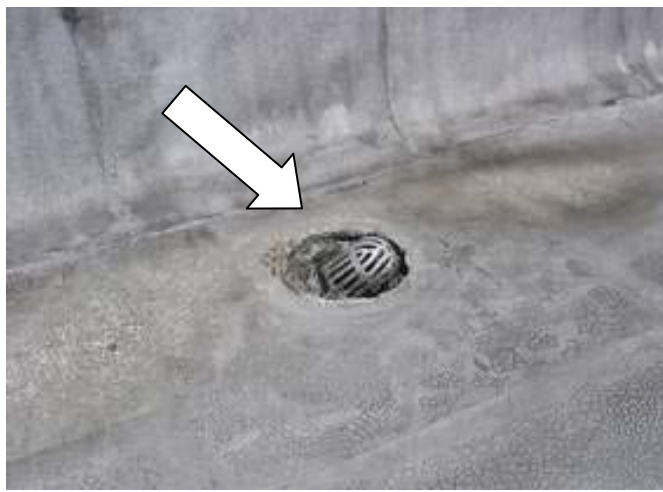
- One roof drain has a screen that is not properly aligned and secured that needs to be repaired. This needs immediate attention.
- One roof drain is partially clogged with debris and is allowing standing water to form a pond around it. This needs immediate attention

This drain screen needs to be secured and properly aligned.

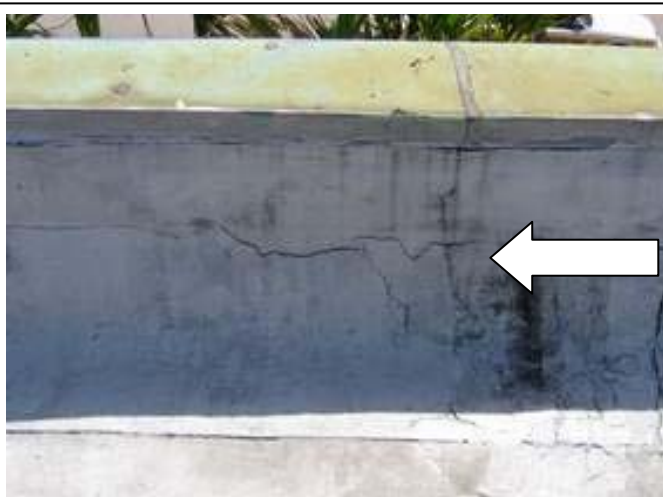
- The surrounding sloped sections of roof over the Station Building appear to be in good condition. No broken tiles were noted.
- The inside surfaces of the parapet surrounding the flat section of this roof is in need of immediate repairs. Splits are forming in the roofing materials where moisture can enter and appear in the ceilings. Several moisture stains were noted in the Amtrak and CSX office areas. Moisture stains were also noted in the wood ceilings between these two areas. It is possible that some moisture is already under the membranes of the flat sections of this roof which may accelerate the need to replace the roof.

There are splits in the water proofing materials along the inside of the parapet surrounding the flat section of the Station Building roof. Water can enter and damage ceilings below and soak any materials under the cap sheets of the roof.

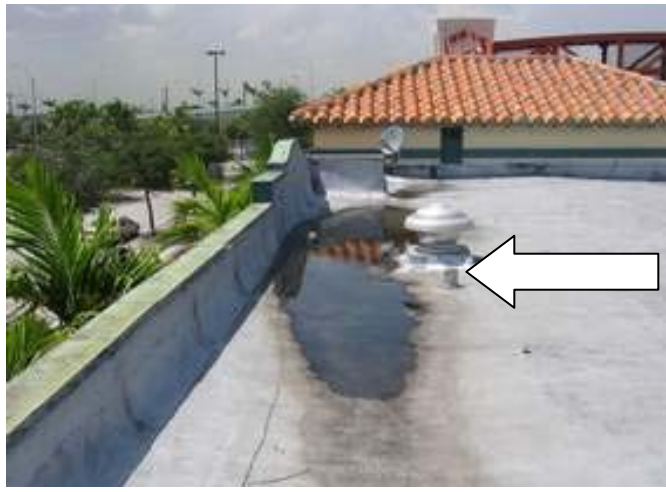
Water pond on Station Building roof. Sloped sections of the roof (in the background) with roofing tiles appear to be in good condition.

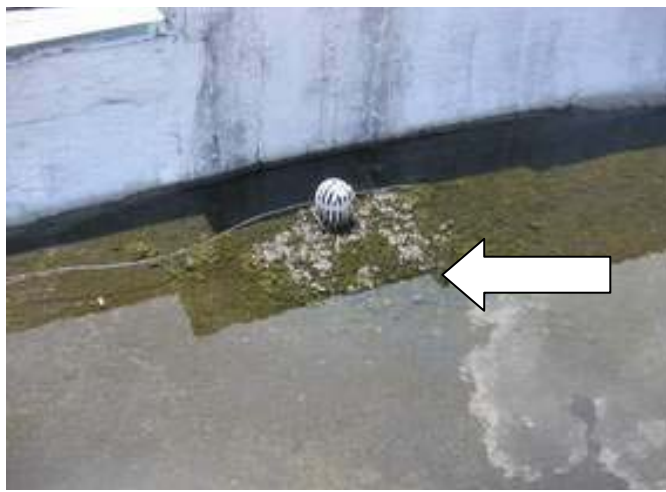
Clogged roof drain area needs to be cleaned and properly pitched to drain properly

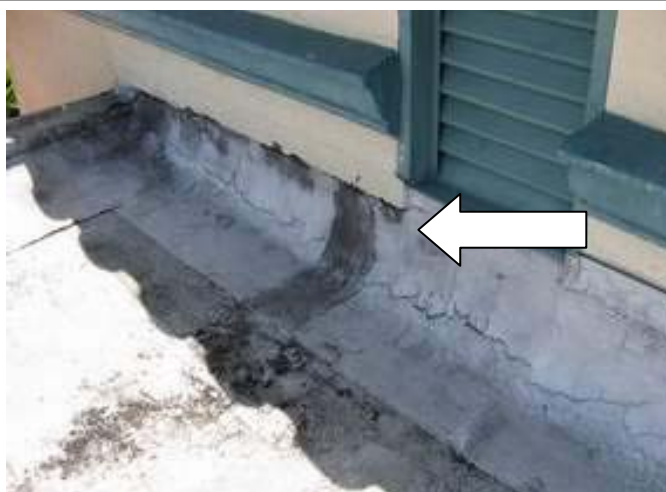
Splits surround the entire flat section of the Station Building roof. There are a few water stains in the Amtrak office area ceilings below this area.

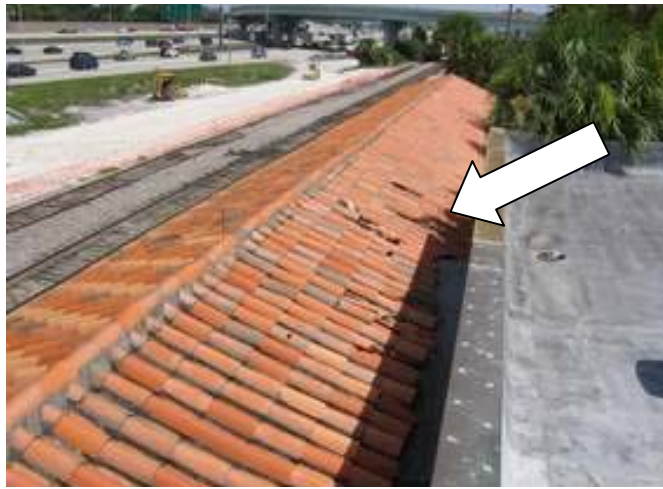
- There are approximately 50 broken tiles in the Loading Platform roof which expose the underlying water proofing materials. A few of these broken tiles are on sections where the slope may cause pieces to slide off the roof. This could cause injury to pedestrian traffic below.
- The roof over this structure appears to be in good condition (except for the broken tiles) and should last more than 5 years. It should be periodically inspected by a roofing contractor and repairs made as necessary.

The adjacent Passenger Loading Platform roof is in need of immediate repairs. This area (looking South) has numerous broken roofing tiles that need to be secured.

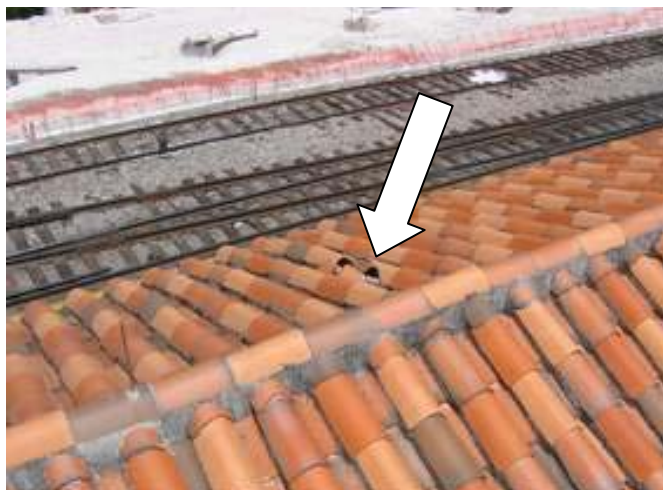
This broken tile can slide off and land on the Passenger Loading Area below

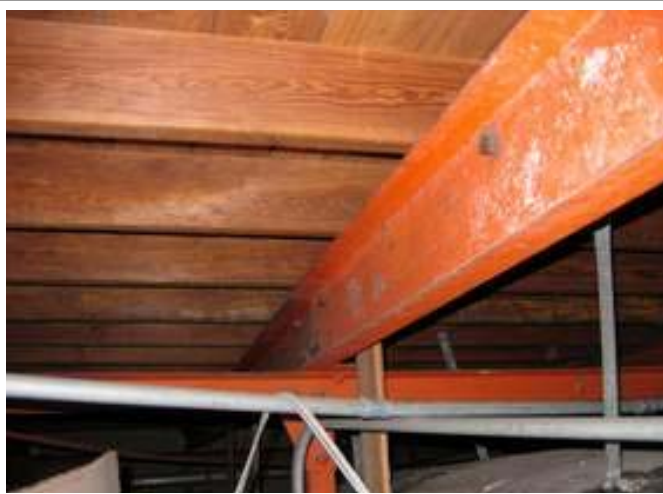
These I-beams supporting the roof do not appear to be from the original construction of the Station Building

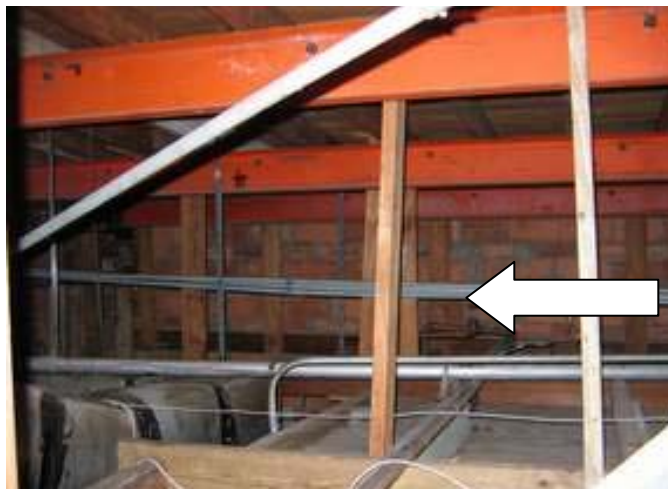
Additional wood bracing and beams have been installed in the attic area supporting the roof and wood plank ceiling below it. Most of this area could not be safely accessed to fully inspect.

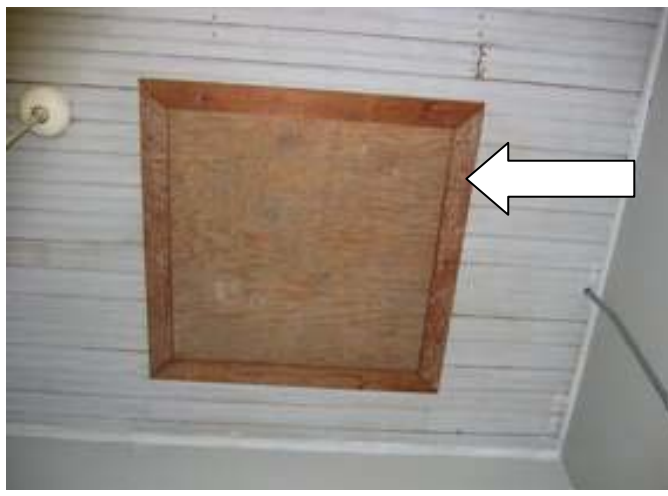
The framing pictures above were taken from the top of this scuttle hatch in the ceiling of the central storage area for Amtrak operations.

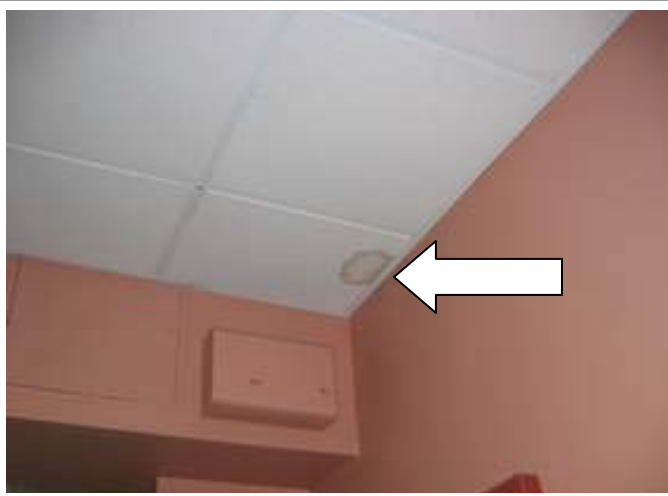
The north section has suspended ceilings with acoustical tiles and modest finishes. All finishes are in reasonably good condition except for moisture stains in the ceilings from roof leaks.

Water stain in ceiling of Amtrak office area is likely from a roof leak

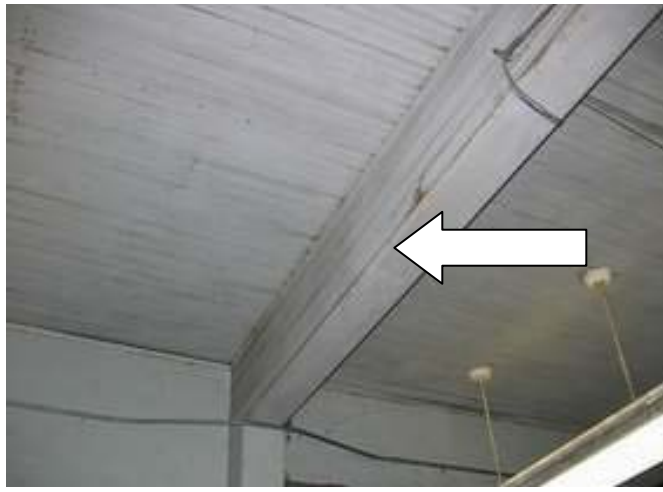
Wood ceilings over the central storage area for Amtrak operations shows sign of past roof leaks

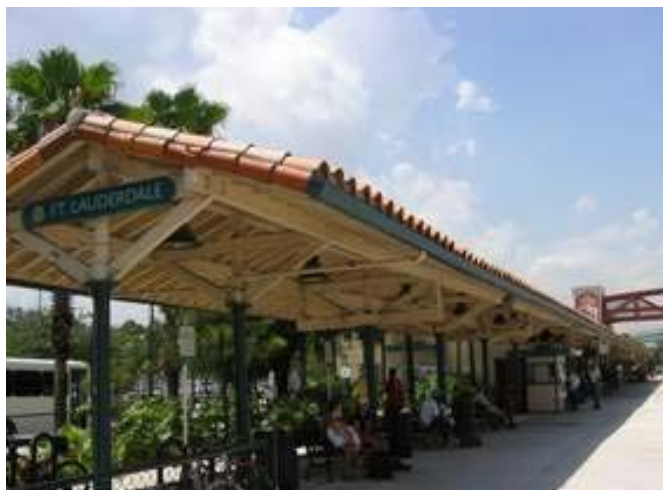
The Passenger Loading Platform is a wood framed structure with steel posts and bolts.

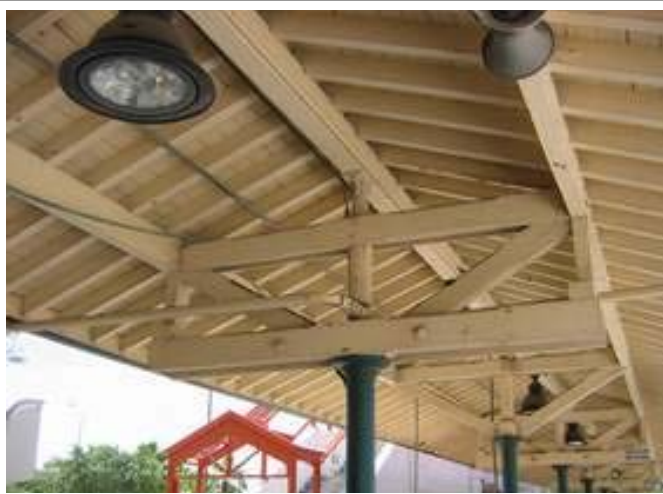
Overall the structure appears to be stable and only has a few elements that need the immediate attention of a structural engineer.

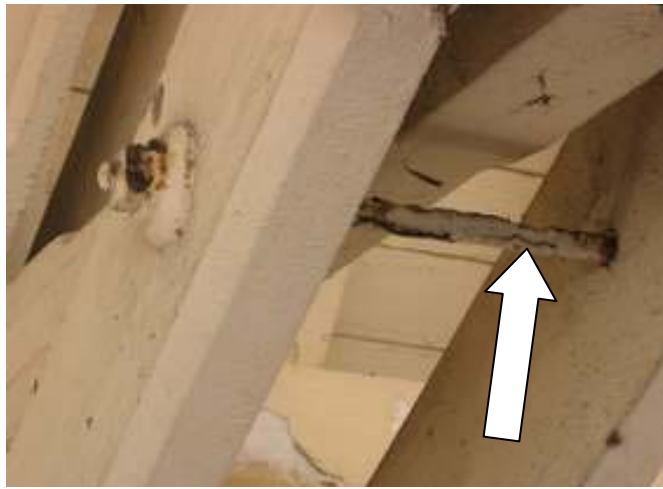
A few of these connecting bolts appear to be significantly rusted and possibly in need of replacement

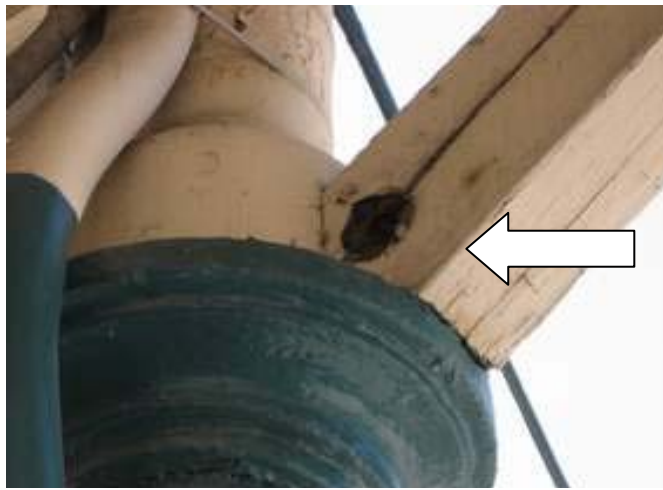
The structure of the passenger Loading Platform appears to also be constructed around 1926. The roof is much newer but there does not appear to be any significant changes to the structural elements. There are small sections of wood rot and termite damage in the framing of the roof. There are also some sections where the wood is split at connection points held in place with large bolts. It would be prudent to ask for the opinion from a structural engineer on two of these areas. (see photos).

This strut is split and should be further addressed by a structural engineer.

5.	Analysis and construction design documents for removal and replacement of damaged structural elements in the Passenger Loading Platform	\$ 5000	IMMEDIATE

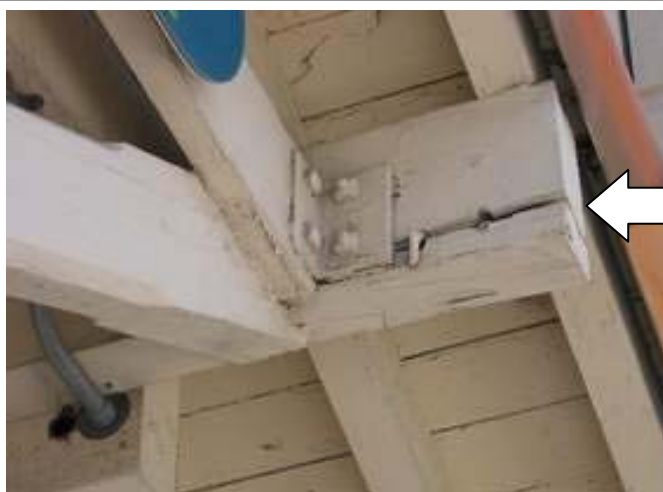
This beam is split at the connection point and needs attention.

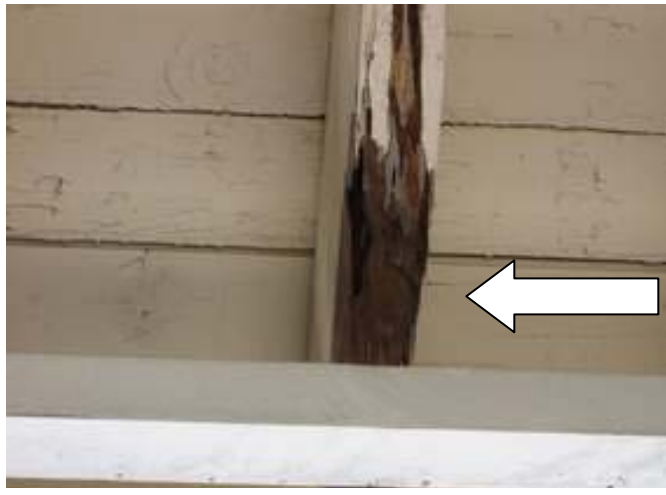
The station manager stated that the Station Building had been "tented" for termites in October 2003. It is not clear if the Passenger Loading Platform was included with this or if there was any previous treatment. It does not appear to be likely that the termite damage is extensive enough to cause failure of the structure.

There is evidence of termite damage in the Passenger Loading Platform. Termites may be active in this structure if it was not included in the October 2003 treatment. It is advisable to coordinate any restoration work and painting with any new treatment. If the old layers of paint are completely removed there are treatments that can be applied to bare wood that will effectively protect the structure for many years against future termite infestations. The station should be painted directly after this treatment.

There are a few termite damaged beams but these do not appear to be in danger of failure.

7.	Possible termite treatment of Passenger Station Platform roof	\$ 1500- \$ 2500	DISCRETIONARY
8.	Restoration and ADA upgrades to three restrooms	\$ 24000	CODE COMPLIANCE ISSUE

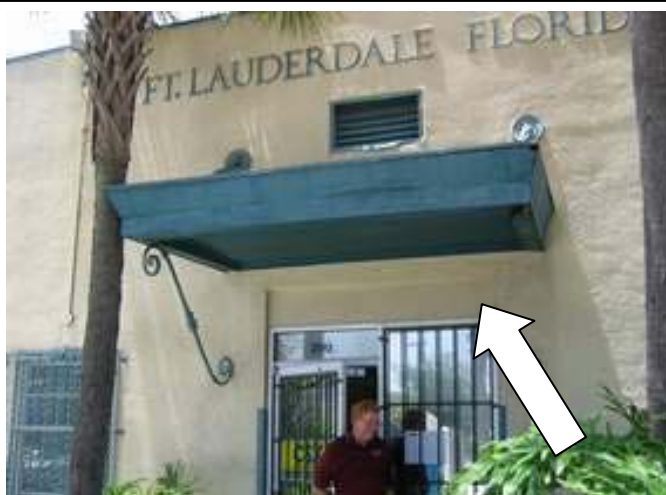
The overhangs are framed out of wood beams and covered with roofing felts. The framing appears to be suffering from wood rot and stress cracks. A decorative strut recently fell from the overhang at the south entrance to the CSX offices. It would be prudent to fully examine these overhangs more thoroughly by removing the trim materials and framing inside the structure covering the connection points. A decision should be made to consider removing these structures and rebuilding them or replacing them with cloth awnings. Cloth awnings have been installed over the entrance doors to the Amtrak office area. It is suspected that these openings were originally similar in appearance to the ones on the south end of the building. They were probably removed and replaced with cloth awnings because of safety concerns.

There are three overhangs like this one still remaining on the building that need to be addressed. Note that the decorative steel strut on right side is missing. The CSX personnel stated that it recently fell

Cost to remove the existing overhangs and replace three awnings with cloth - \$ 4500

Cost to rebuild three overhangs to original appearance - \$ 7500

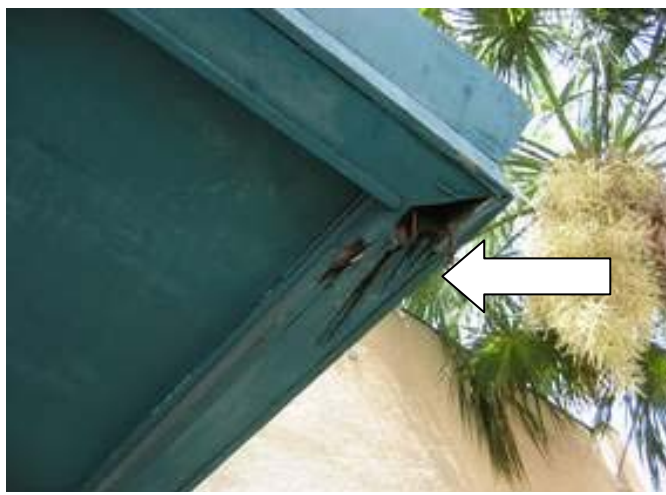
Wood is rotted in these overhangs. There may be concerns hidden where the support chain is connected

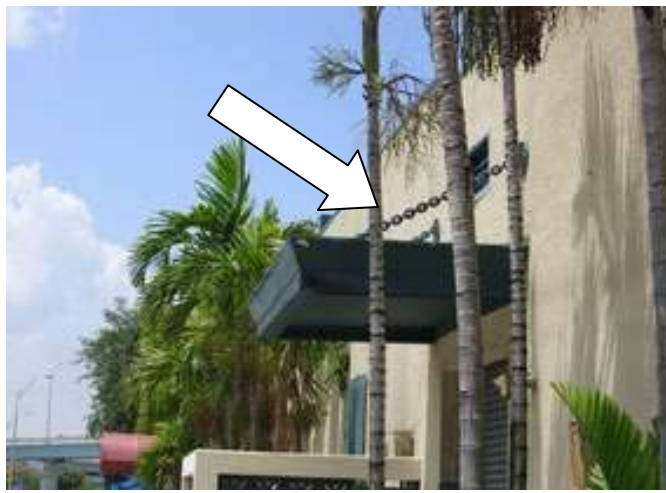
There are three overhangs over the west and south sides of the building. They are supported by chain that is anchored to the walls of the structure. The condition of the anchor points could not be viewed because of framing inside the structure obscuring the view.

The attachment points for the support chains for these overhangs are not accessible. It is advisable to remove these old structures and replace them with new materials or cloth awnings.

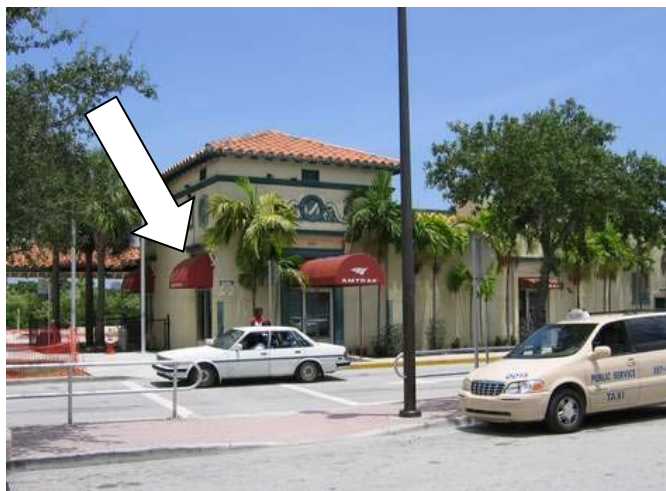
Cloth awnings have been installed over entrances for the Amtrak operations area.

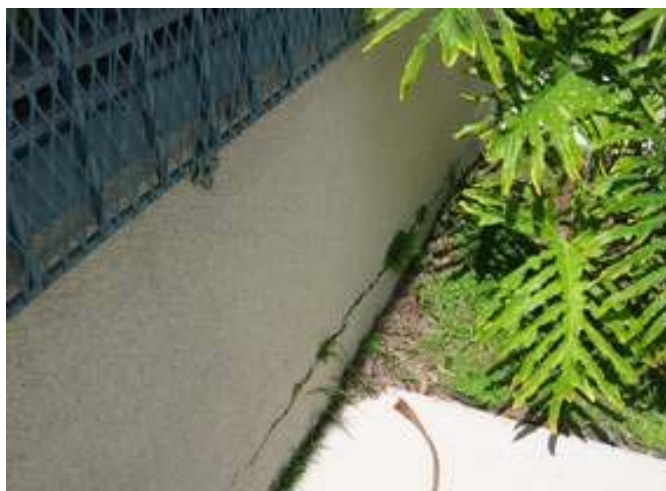
The Station Building shell appears to be in good condition and there were no structural defects noted. The exterior masonry walls appear to be sound. There is only one location where a significant crack has appeared. This is located at the south end of the structure. (see photo) This area appears to be a cosmetic issue.

This crack in the stucco along the south wall of the Station Building needs to be repaired to keep water from entering the interior.

11.	Repair of stucco crack on south side of Station Building	\$ 200	IMMEDIATE
12.	Repair of wood rot on exterior of southwest window frame	\$ 200	IMMEDIATE

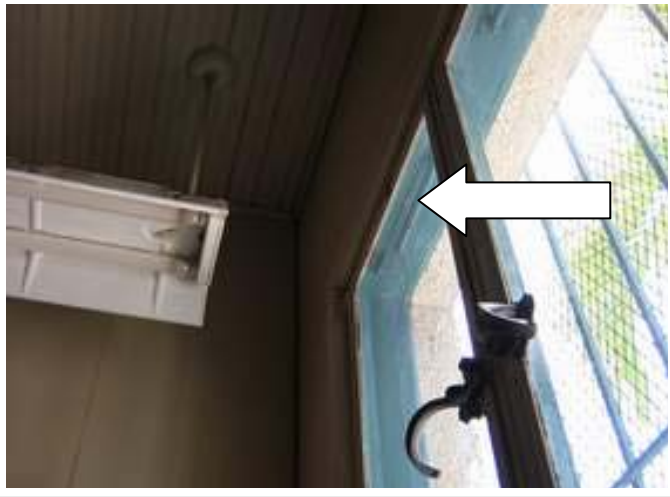
The windows and frames appear to be in good condition in the Station Building

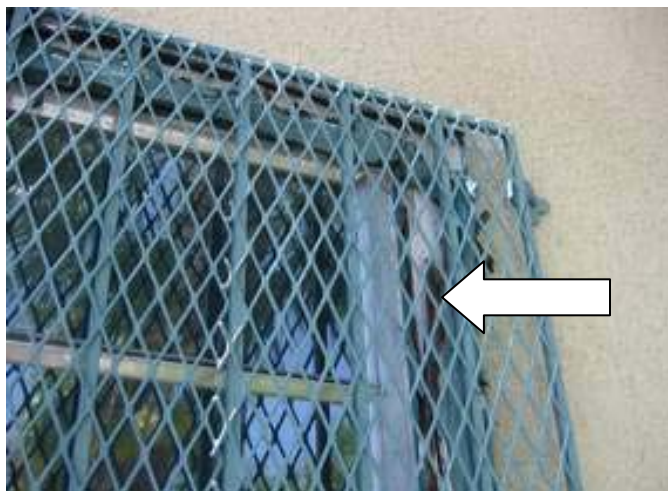
Wood rot along exterior of window on southwest side of the Station Building needs to be repaired.

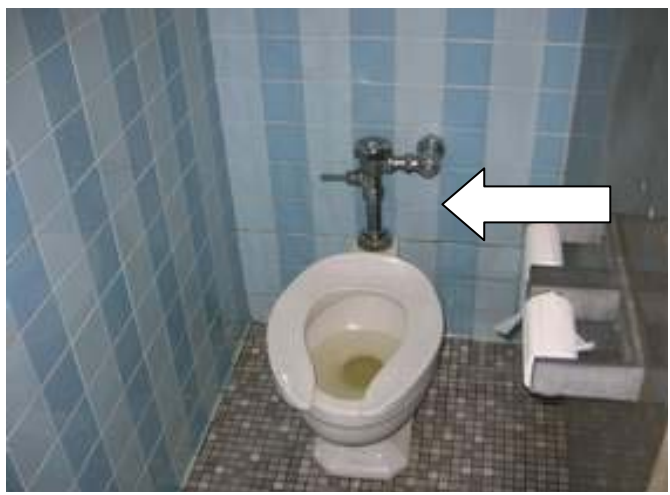
The restrooms in the north and south section are in fair condition but do not appear to meet minimum ADA requirements.

The restrooms in the Station Building are in good repair but do not meet ADA requirements. They are lacking proper clearances, handrails, partitions and fixtures.

Cost for restoration and ADA upgrades to the three restroom facilities - \$ 24,000

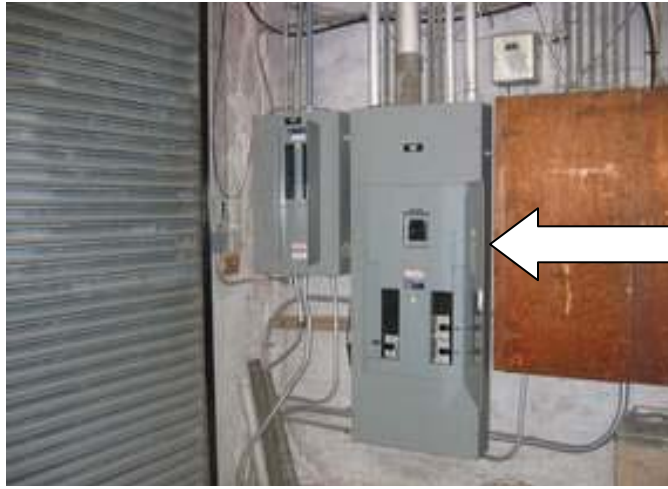
New service panels have been recently added to the Station Building. Overall the electrical system appears to be in good condition.

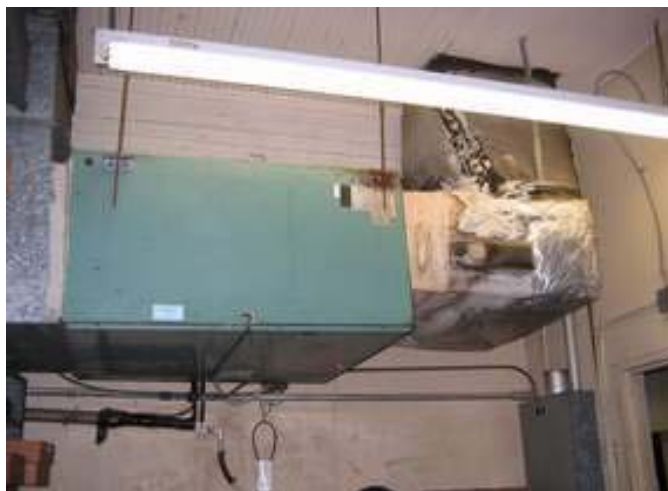
The condensing unit and the air handler serving the Amtrak Office and Customer Service Area are older units. This system appears to be functioning properly but should be considered for replacement to improve efficiency and reliability. A review of any available past service records might assist in making a decision on when to replace the unit.

This old air handler supporting the Amtrak office area may need to be replaced in the near future. It is currently functioning.

Cost of replacement of entire system - \$ 5000 - \$ 7500 (discretionary)

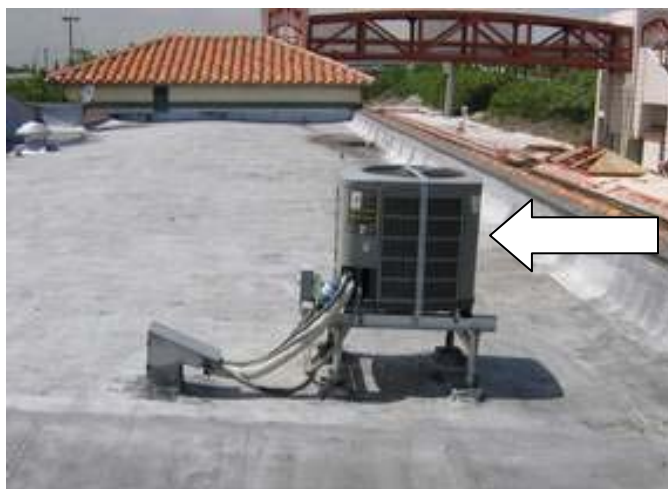
The condensing unit for the A/C system supporting the CSX office area is new and in good condition.

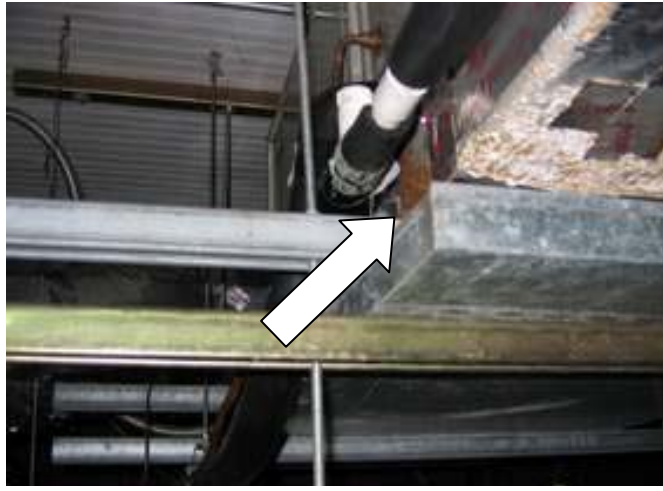
The condensing unit for the CSX office space is new but the air handler for this area is old. The housing is corroded and condensate has leaked onto the ceiling tiles. It is currently not leaking but appears to be in need of immediate replacement.

The air handler over the CSX office area needs to be replaced. It has leaked and the housing is corroded.

Replacement cost - \$ 1500 - \$ 2000 (immediate need)

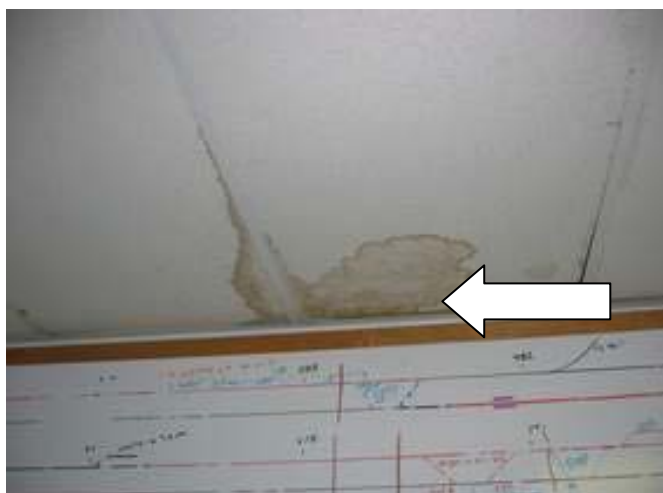
The south section has suspended acoustical tile ceilings and modest finishes which are all in relatively good condition except for water stains from A/C condensate.

Condensate stains from the air handler above the ceiling in the CSX office area.

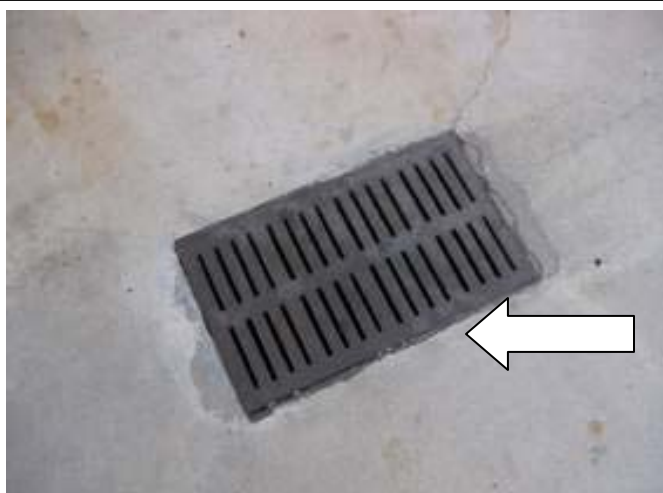
Site drains appear to be clear on the Passenger Loading Platform and in the parking areas. These need periodic cleaning and flushing to remove silt or they will clog and the lines will need replacement

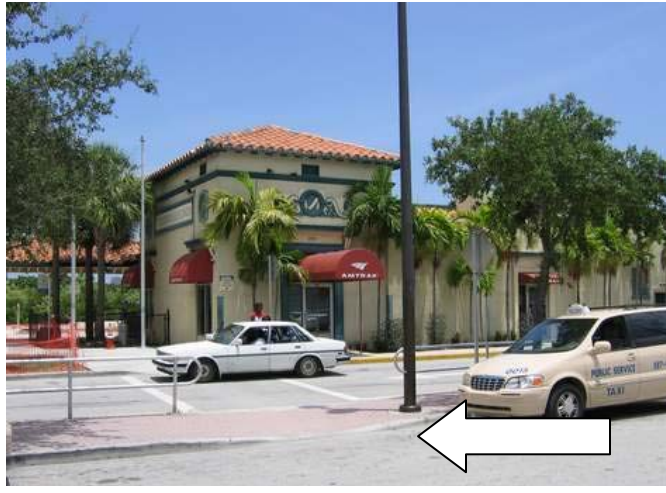
The parking facilities appear to be designed for Accessibility requirements with proper ramps and parking spaces.

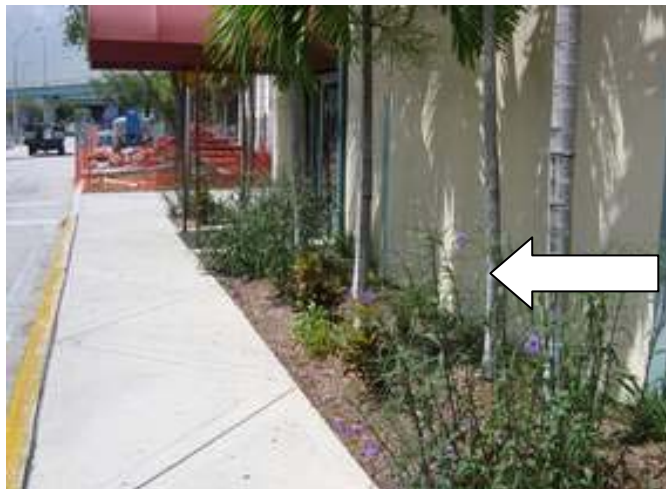
Landscape near the front entrance to the Amtrak operations is in need of attention.
