## Property Condition Assessment Summary Report

**File Number:** 05-15-C-001

**Inspector:** Craig Milliken, PE # 32779  
CPM Real Estate Inspections, Inc.

**Date of Inspection:** April 27, 2006

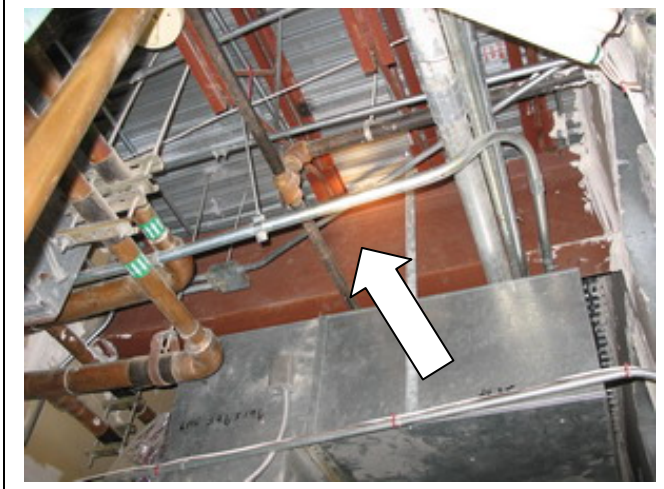
Photo # 1

Most structural elements are hidden from view. All elements viewed are in good condition.

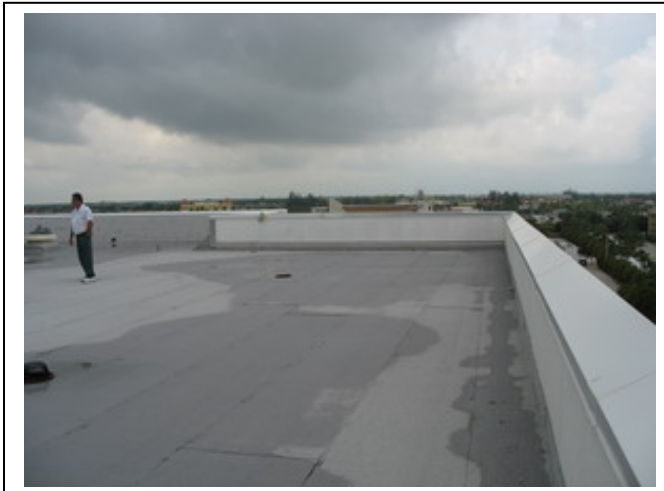
Photo # 2

The roof is in new condition and professionally installed.

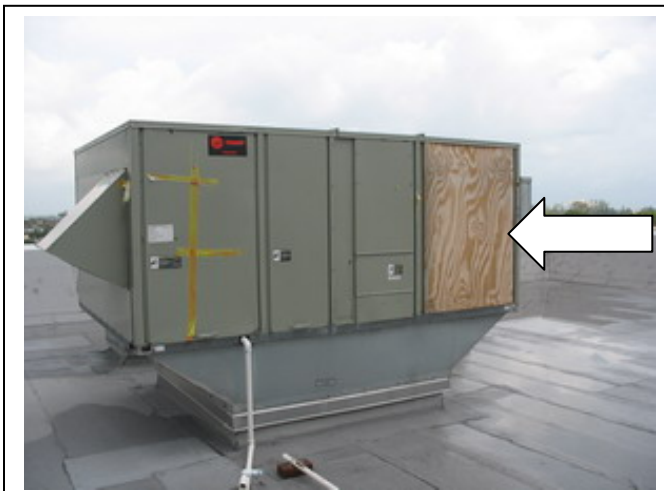
Photo # 3

Two RTUs were damaged from hurricane Wilma. Plywood was used to cover access panels as a temporary measure.

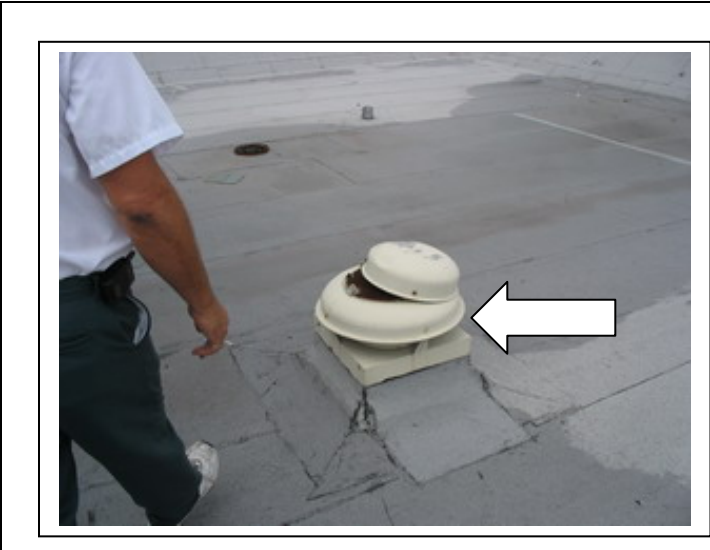
Photo # 4

Roof top powered ventilator damaged from hurricane Wilma.

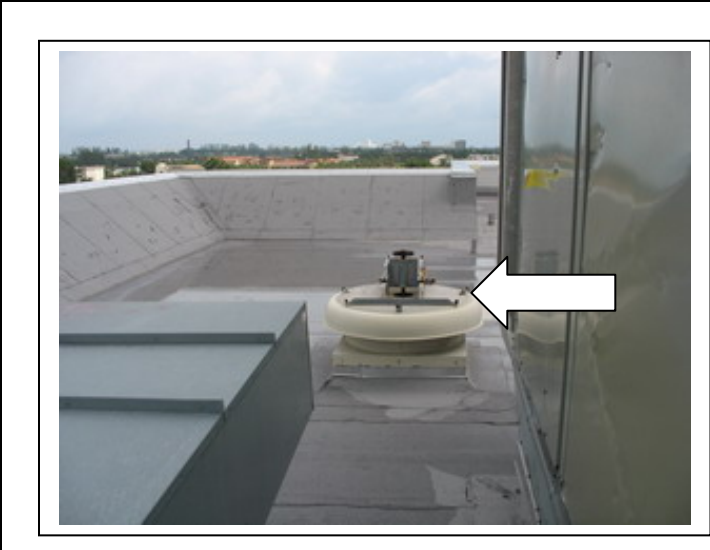
Photo # 5

Roof top powered ventilator damaged from hurricane Wilma.

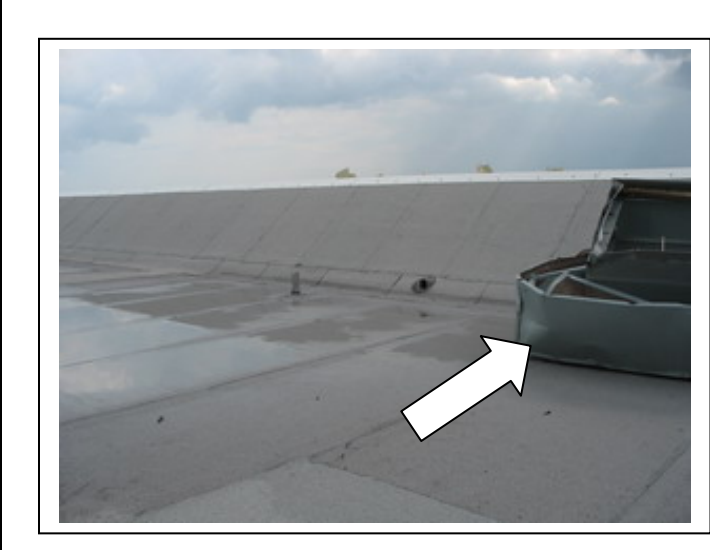
Photo # 6

Rain cap from one roof top powered ventilator needs to be removed from the roof.

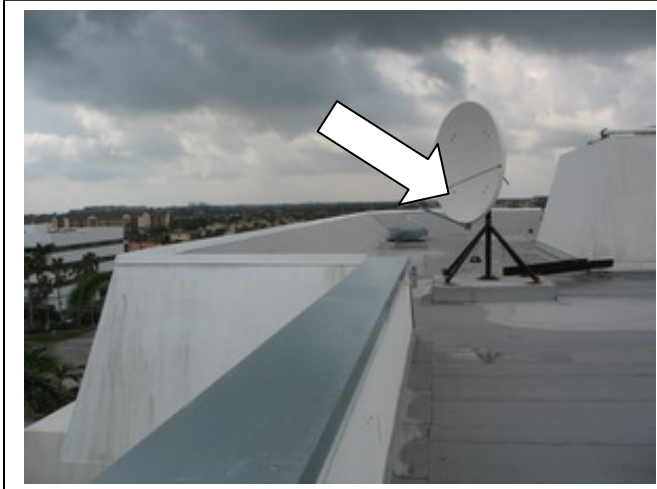
Photo # 7

Dish antenna on roof needs to be removed if it is no longer being used.

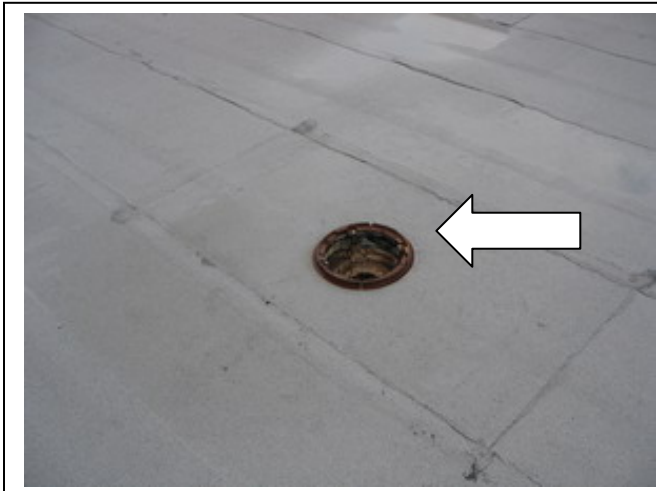
Photo # 8

One roof drain screen is missing.

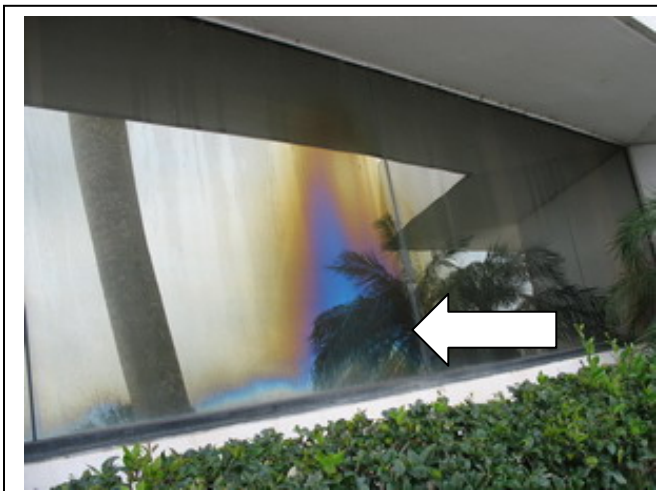
Photo # 9

Glass tint on several windows is discolored. The window is water tight.

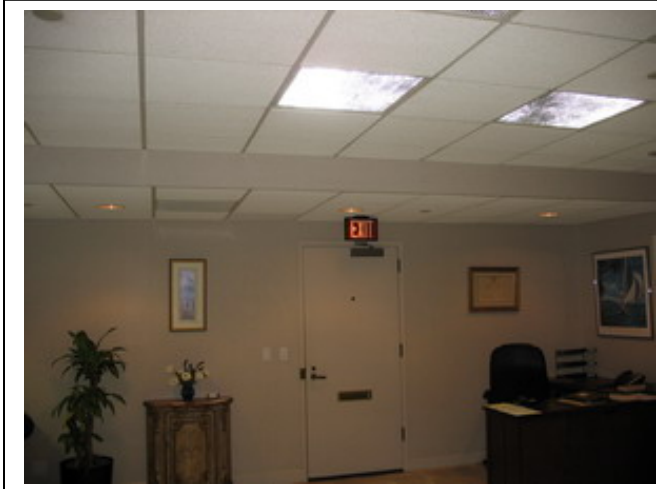
Photo # 10

Building interiors are in good condition.

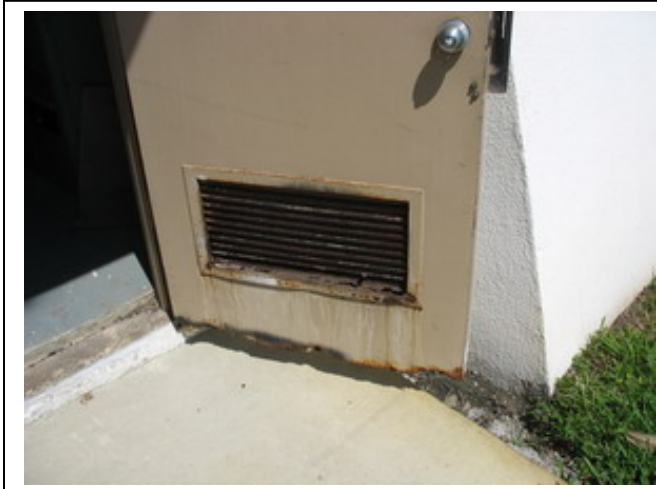
Photo # 11

Exterior metal doors on the utility rooms need to be considered for replacement.

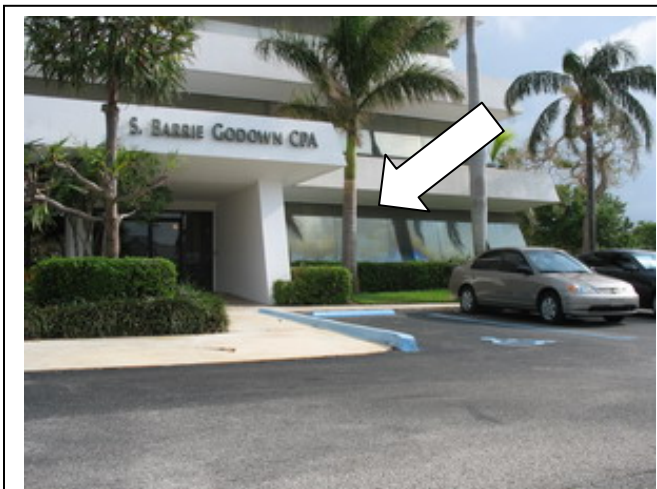
Photo # 12

2.	Are Accessible Spaces properly sized? Standard Accessible – 96" W – 60" aisle – 80" H Van Accessible – 96" W – 96" aisle – 98" H Universal Accessible – 132" W – 60" aisle – 98" H		X		ALL EXISTING SPACES ARE UNDERSIZED

3.	Are Accessible Spaces marked with vertical signs?		X		SIGNS MISSING ON SOUTH SIDE
4.	Are Accessible Spaces marked on the pavement?	X			
5.	Is there an accessible route from public transportation, passenger loading zones, public streets and sidewalks?	X

Sign missing on south ADA accessible space.

The spaces are not wide enough or properly marked to meet the 1991 ADA code.

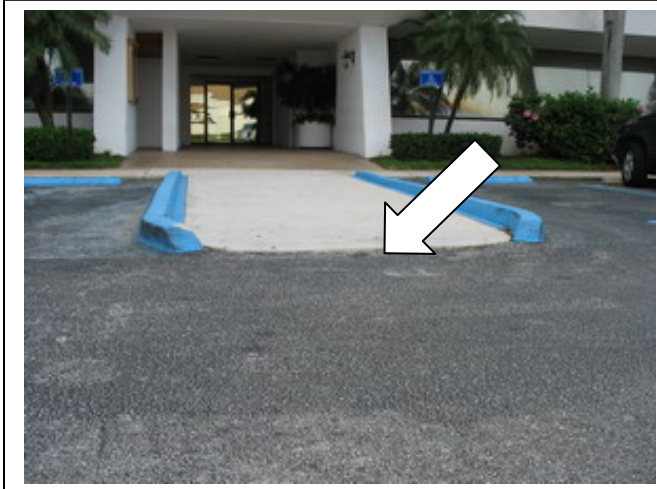
Photo # 13

2.	Are there any floor obstructions greater than ¼" high requiring beveling or ramp/		X		RAMPS HAVE EDGES AT ASPHALT PAVEMENT OVER ½ INCH HIGH

The asphalt is not level with the concrete ramp in three locations. This is an ADA barrier that needs to be removed.

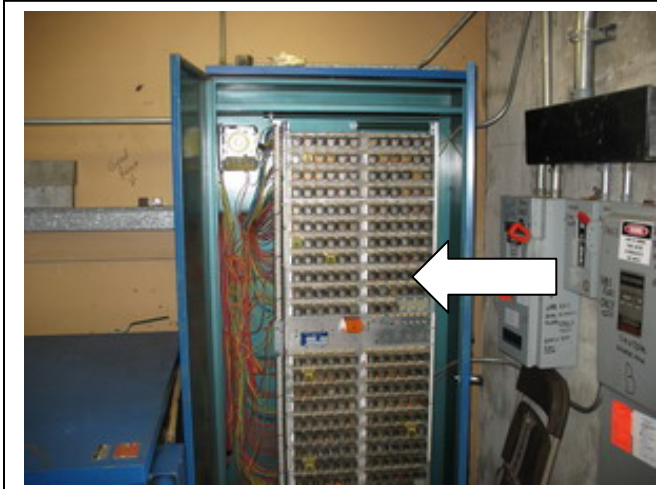
Photo # 14

- The elevator's controller is an old electromagnetic relay type that is nearing the end of its reliable service life and will need replacement within the next few years.
- The existing controller does not have the capability to meet current code requirements to provide Phase II fire recall. This feature allows emergency personnel to control the elevator movement between floors.
- Should major renovations occur in the building, a new solid state controller will need to be installed. The cost of this upgrade is approximately \$ 70,000.

Original elevator control panel is near the end of its reliable service life and does not have Phase II fire recall capabilities.

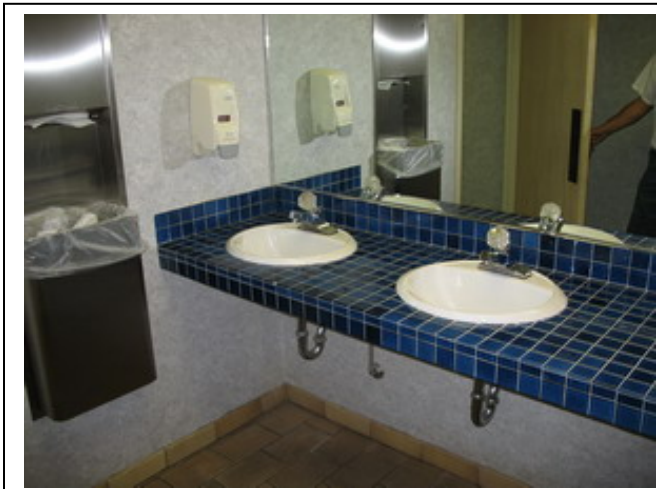
Photo # 15

The restrooms do not meet several areas of the ADA code. These sinks do not have lever type fixtures.

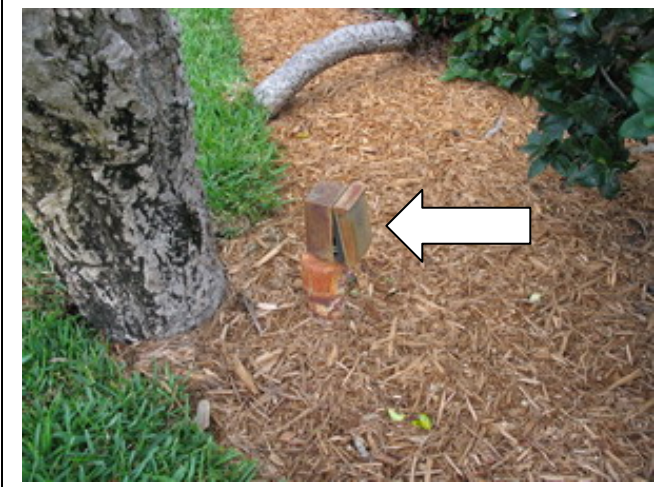
Photo # 16

Junction boxes on the exterior of the building need repairs to make them water tight.

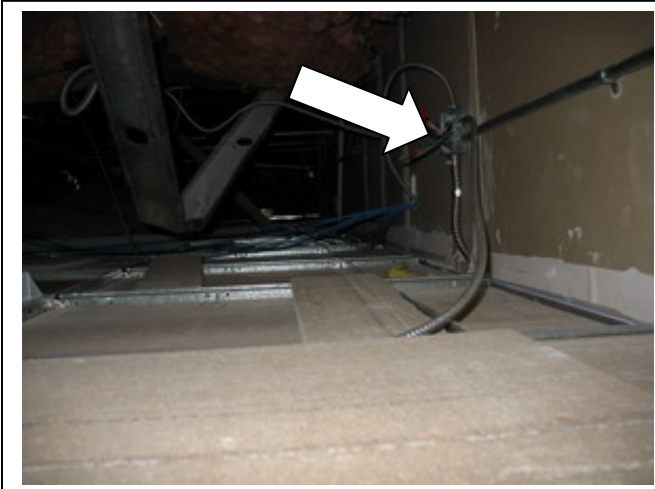
Photo # 17

- Several junction boxes have loose or missing cover plates in areas above the suspended ceilings. These should be secured by an electrician.
- Several junction boxes in planted areas surrounding the building have loose cover plates that need to be secured.

Several junction boxes above the suspended ceilings need cover plates.

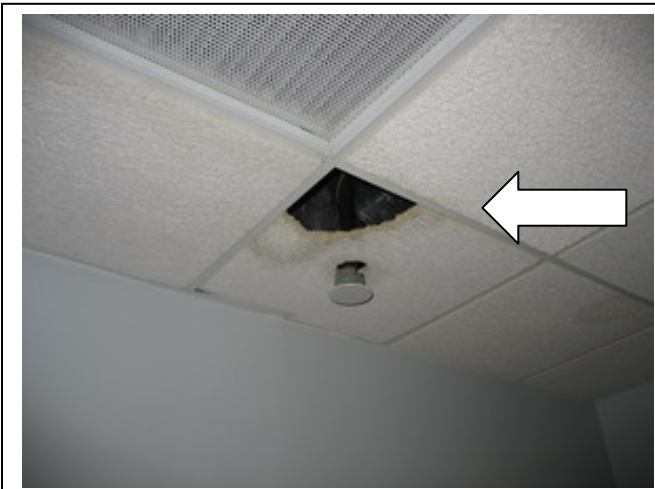
Photo # 18

Damaged ceiling tile from old plumbing leak.

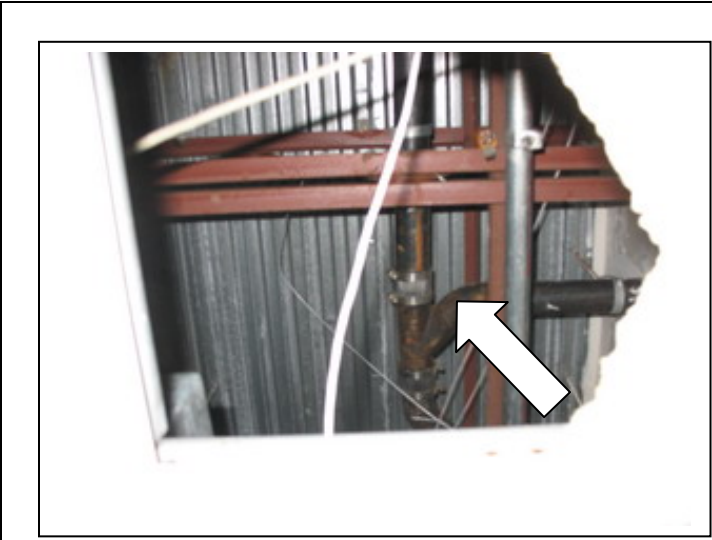
Photo # 19

Fittings on the waste line above the previous photo were disturbed when a plumber was clearing the line. The line is now repaired.

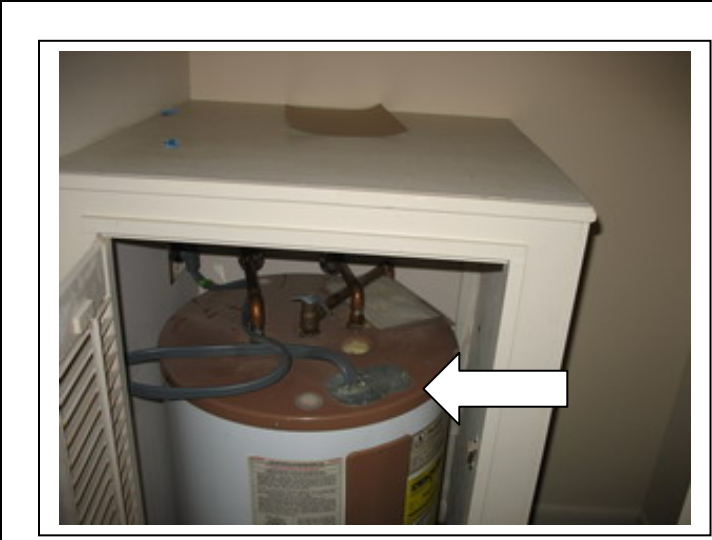
Photo # 20

A few of the tenants have their own hot water heaters. The building's common area restrooms do not have hot water.

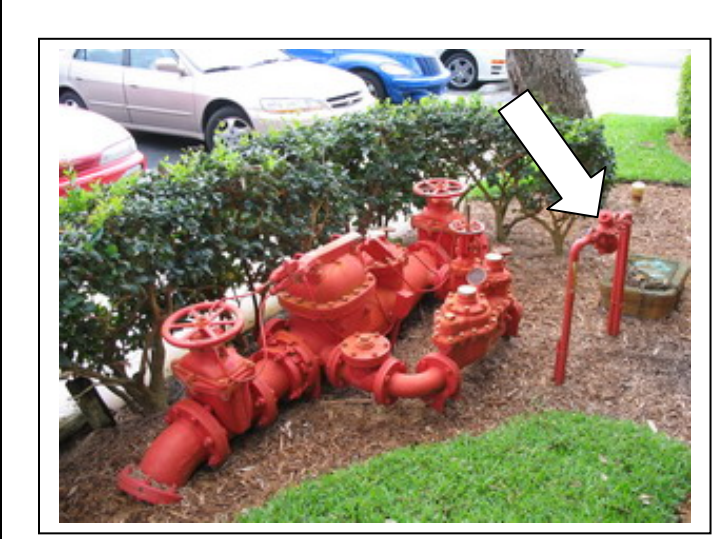
Photo # 21

The small backflow prevention device is likely not the main domestic water connection.

The large backflow prevention device to the left is for the fire sprinkler system.

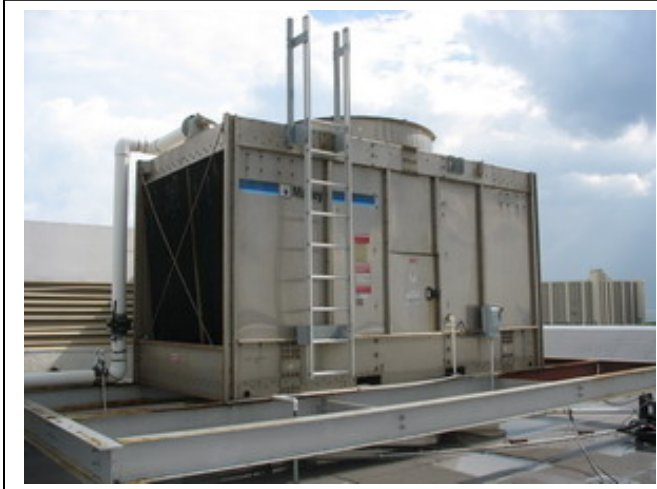
Photo # 22

New stainless steel roof mounted cooling tower.

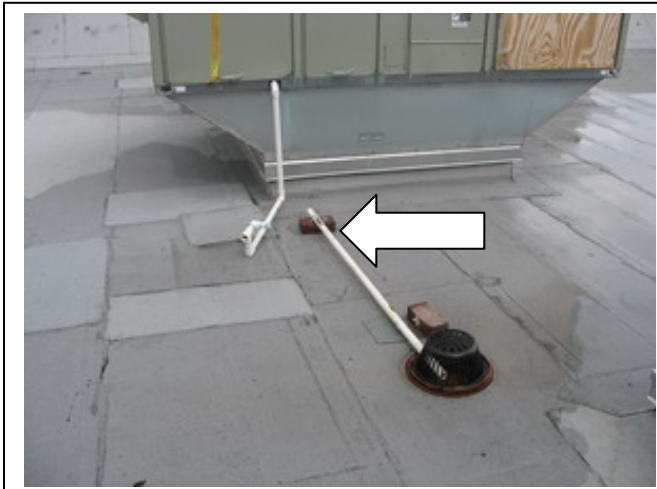
Photo #23

Broken condensate drain line from RTU needs to be repaired.

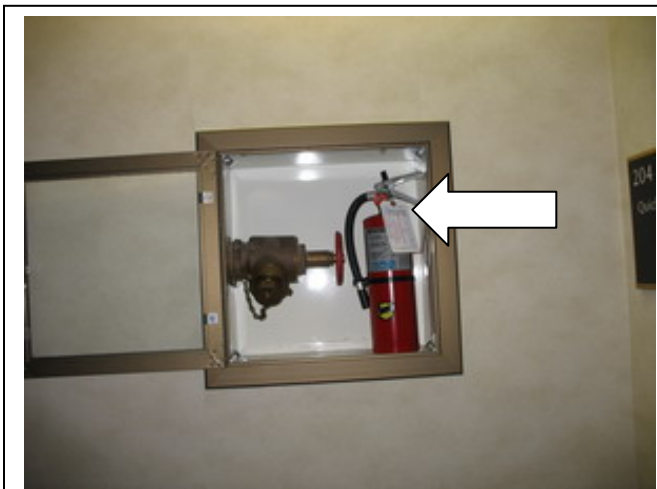
Photo # 24

Fire extinguishers have current inspection tags.

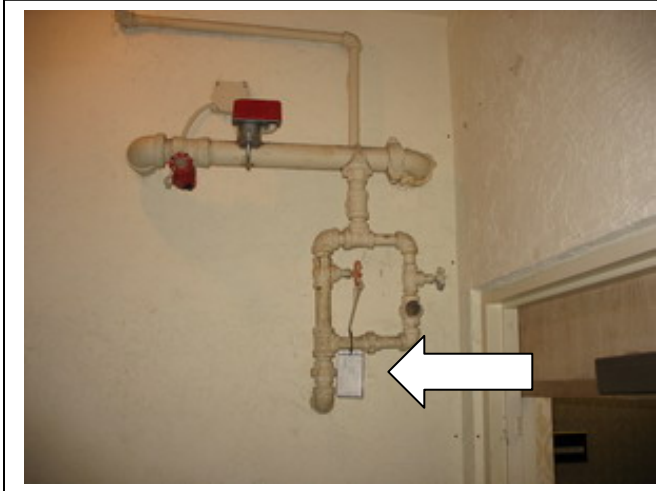
Photo # 25

Fire sprinkler test stations have current inspection tags.

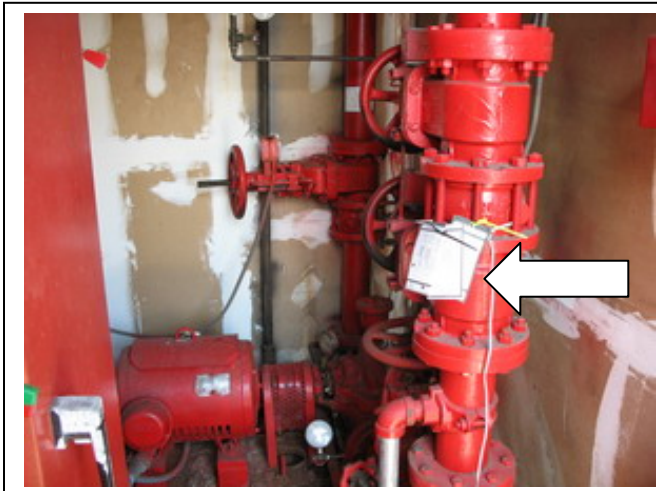
Photo # 26

- The backflow prevention device and the fire pump did not appear to have current inspection tags. Tom Harris of Gator Fire Protection stated that all inspections were current. These tags need to be located.

Current inspection tags for the fire pump were not found on site.

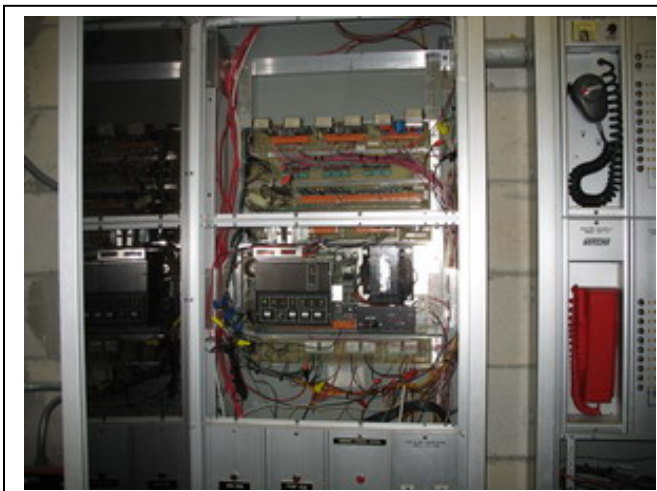
Photo # 27

- Josh Woluk of Florida State Fire and Safety stated that the panel is aging and that repair parts are becoming increasingly difficult to obtain.
- Any major renovations to the building will require a new fire panel and some additional wiring. The cost of this upgrade is approximately \$ 30,000.
- There appear to be an adequate number of emergency light packs, fire extinguishers, illuminated exit signs and smoke detectors in the building. However, should major renovations occur, additional strobe lights and audible enunciators will be required in each restroom to comply with current ADA standards.

The original fire alarm panel is beyond its reliable service life and will soon need replacement.

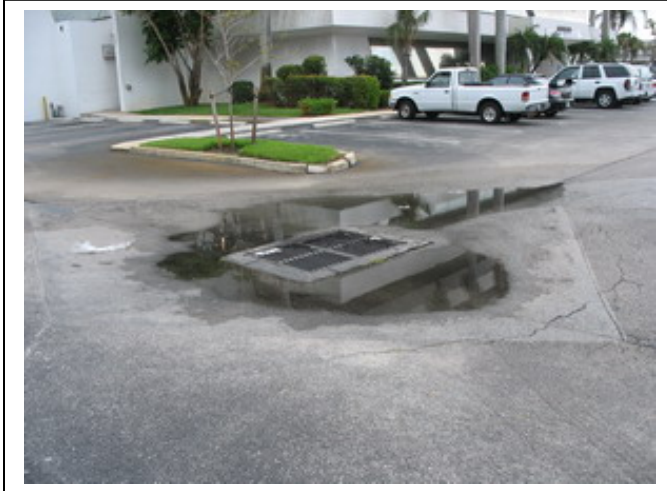
Photo # 28

- Small ponds of standing water were noted near three drain openings in the drives surrounding the building. These ponds are due to inadequate pitch near the drains. These problem areas could be corrected by a paving company for minimal expense. This is not considered a significant problem as the ponds are easily avoided by pedestrian and automotive traffic.

Small ponds of water around the drain openings in the drives are due to inadequate pitch.

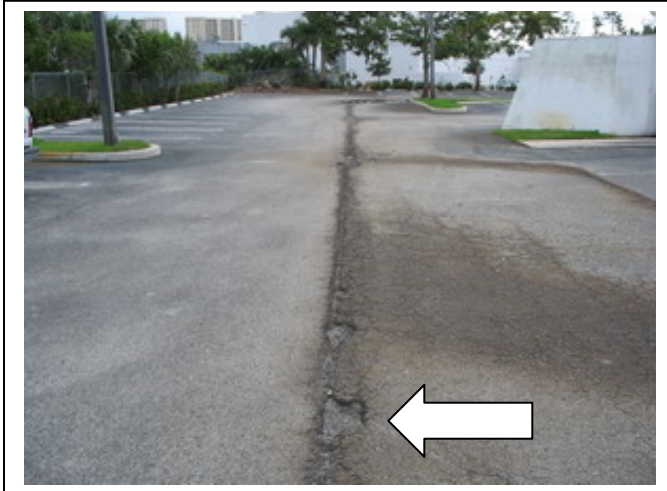
Photo # 29

Several areas of the drives need to be repaired.

All asphalt surfaces need to be seal coated and re-striped.

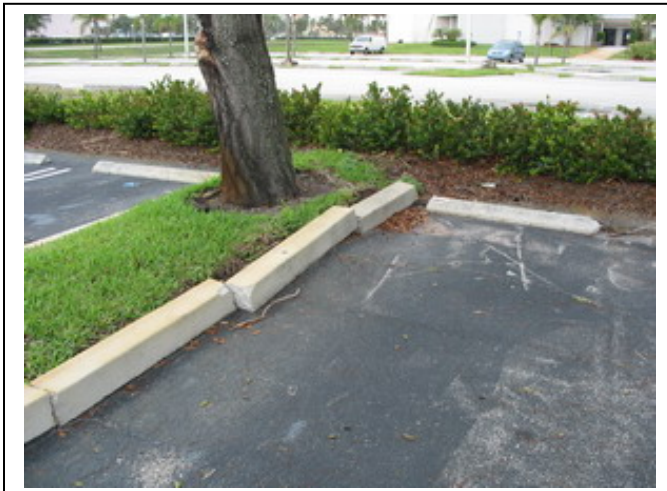
Photo # 30

Curbs are broken in several areas from tree root growth and vehicle traffic.

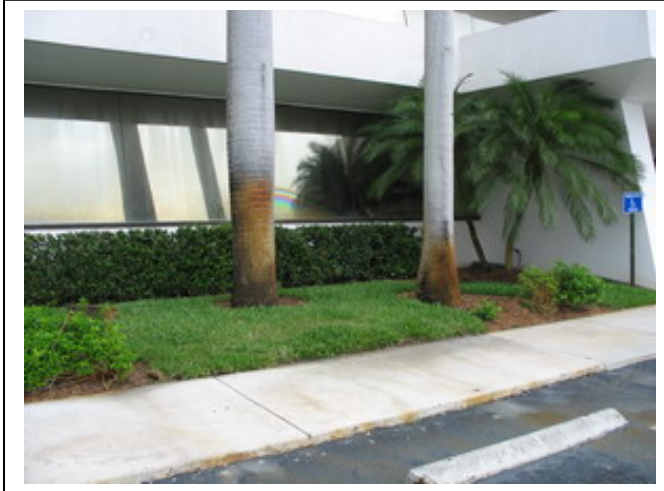
Photo # 31

- Water from irrigation sprinklers has stained some of the first floor's exterior walls and windows. This is a cosmetic issue.

Staining from the irrigation system.

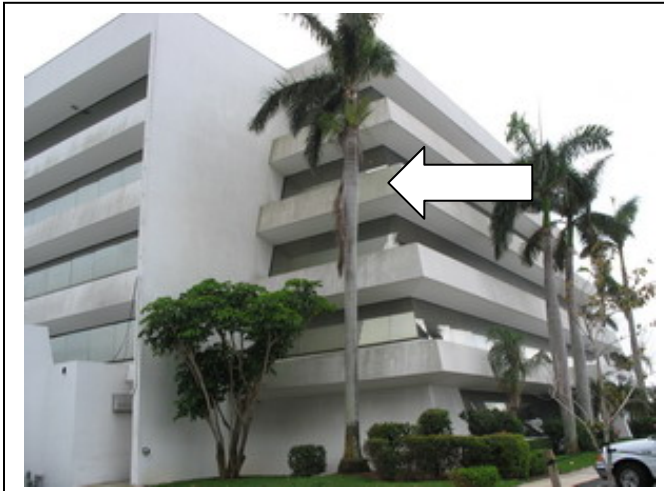
Photo # 32

- Mildew stains on the north exterior walls of the building should be removed by pressure cleaning. The appearance of these exterior stains can affect the perception that visitors and tenants have of the cleanliness of the building.

Walls on the north side of the building have mildew stains that should be removed.
