Standard Home Inspection Report

File Number: 05-15-011

Type of Property: Single Family Home

Date of Inspection: 05/05/2006

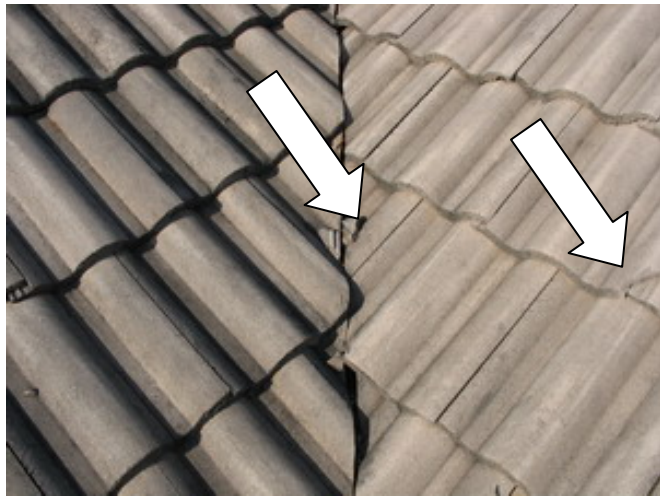
Photo # 1

RAINWATER RUNOFF FROM ROOF NOT CHanneled AWAY FROM ENTRANCES		NO
Comments:		
<ol style="list-style-type: none"> 1. This roof appears to be professionally installed and in a water tight condition. 2. Approximately 20 tiles have small chips that should be mended. 3. Three tiles are cracked and need to be mended. Cost of roof repairs - \$ 50 - \$ 250 (all roof repairs can easily be performed by a good handyman. A roofer is not required)

Approximately 20 tiles have small chips that need to be replaced.

The loose chips need to be sorted to the location where they came from and mended with roofing caulking.

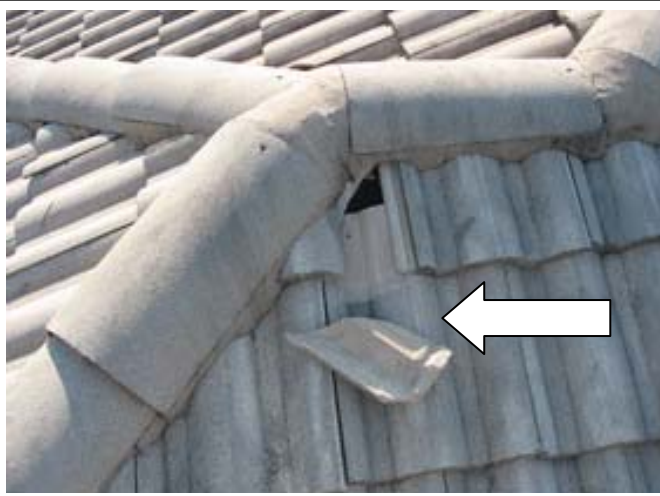
Photo # 2

Three tiles similar to this one have fractured and need to be mended with roofing caulking.

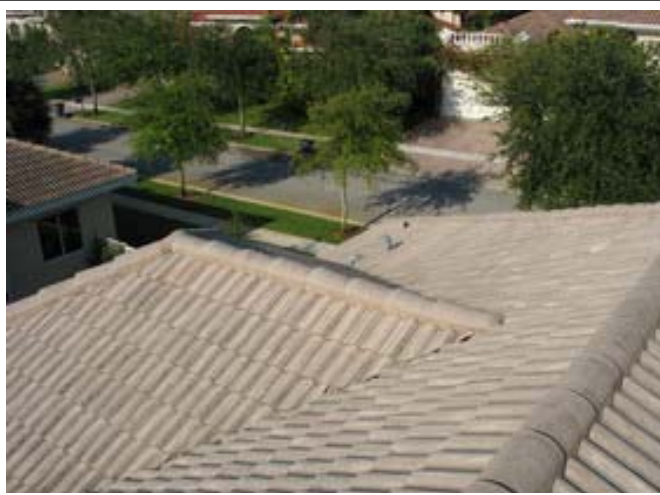
Photo # 3

Overall the roof is in a water tight condition. All tiles are secure and in the proper place. This was a very good roofing job.

Other similarly shaped roofs in the neighborhood did not fare as well after hurricane Wilma.

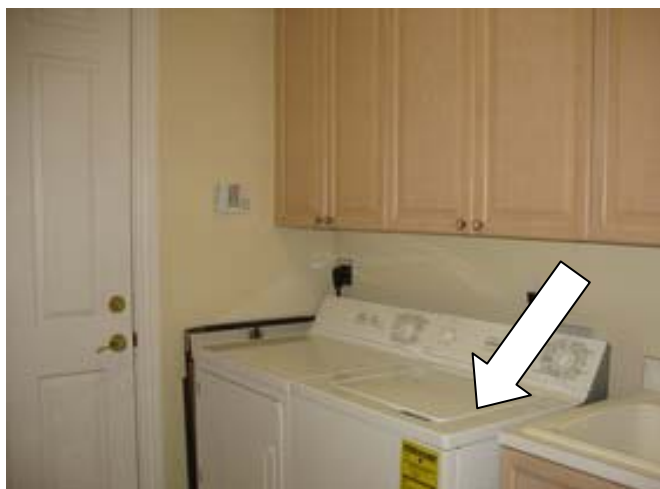
Photo # 12

INSTANT HOT WATER DISPENSER		
DEVICE NOT FUNCTIONING PROPERLY		NO
TRASH COMPACTOR		
DEVICE NOT FUNCTIONING PROPERLY		none installed
Comments:		
<ol style="list-style-type: none"> 1. Clothes washing machine was noisy and may need servicing. Cost – unknown 2. Hot and cold water supply hoses on the clothes washing machine should be changed as a precaution. Cost - \$ 25 - \$ 50

Clothes washing machine was noisy when running. It likely needs some repair.
