## Standard Building Inspection

### Summary Report

**Subject Property:** 750 South Federal Highway, Pompano Beach, FL

**Date of Inspection:** Tuesday, March 15, 2005

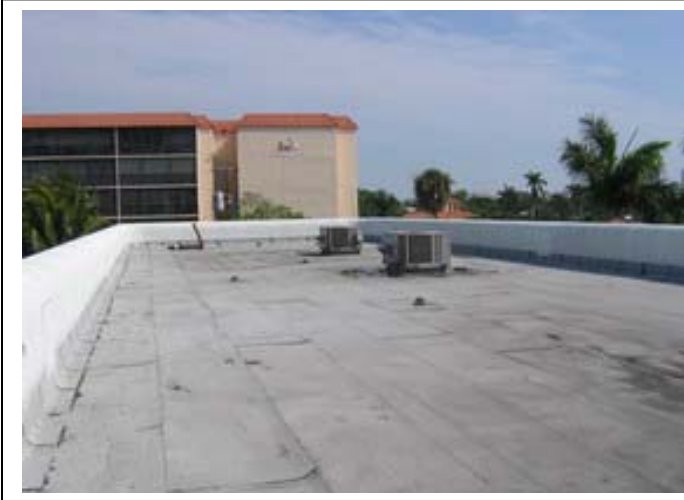
Photo # 1

**Roof** – The roof is a flat built-up design with a cap sheet that is lapped and sealed with hot moped asphalt and coated with a UV protective granular surface. Some minor pitch is present that allows water to flow to several roof drains located in the center of the roof. Overall, the roof appears to be in a water tight condition; however, the following conditions were noted:

Overall the roof appears to be in a water tight condition and should be under a warranty.

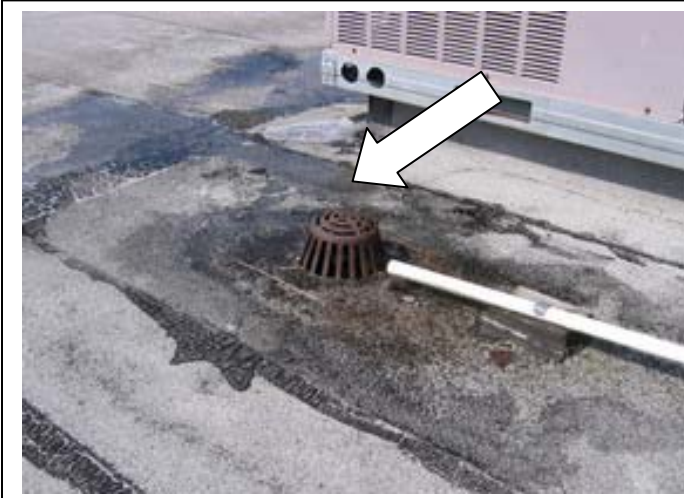
Photo # 2

- The roof drains are located towards the center portions of the roof. The granular surface sheds and these gritty particles are forming dams against the drain openings. Water is forming small ponds around the drains. The grit needs to be periodically cleared away from the drains. Standing water can accelerate the deterioration of the roofing materials. This is an ongoing maintenance issue needing attention every few months or sooner if required.

Granules are blocking the roof drains and need to be periodically cleared.

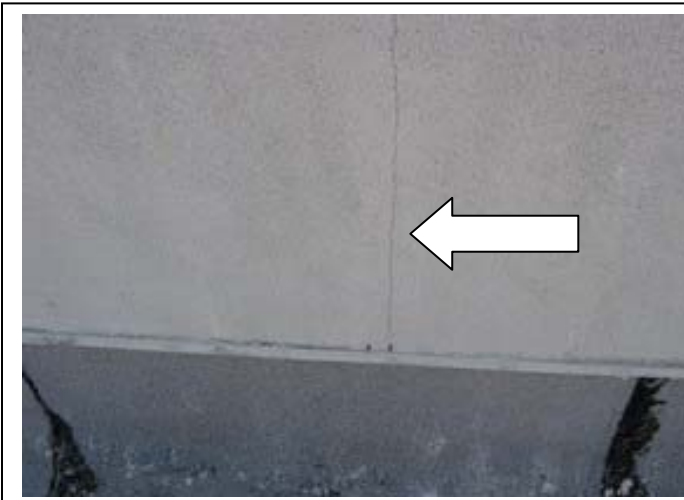
Photo # 3

- Corrosion was noted on the ends of the steel joists that support the roof inside the parapet wall. The four foot high parapet surrounding the roof has joints that have small stress cracks in the surface. These cracks appear to be minor but may be responsible for some of the moisture stains and corrosion noted inside the cavity. The corrosion appears to be affecting only the surfaces of the exposed steel joists and not diminishing their structural integrity at this time. These areas should be inspected periodically.

Flashing along the inside of the parapet walls appears to be in good condition.

These small cracks in the parapet are along joints and they may be leaking.

A water hose can be used by a maintenance person to flood these cracks to see if any of them are leaking.

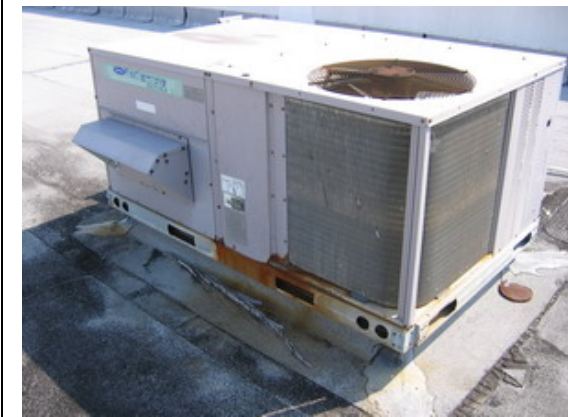
Photo # 4

- The three package type systems have a significant amount of corrosion along the bottom of the frames. This corrosion can lead to leaks under the units. There is no indication of leaks at this time; however, they need close monitoring by the service company.

- All of the RTU's are on curbed roof openings. All roof penetrations associated with these units appear to have been professionally performed and water tight.

Roof penetrations and curbed openings all appear to be water tight, however, corrosion along the base of the RTU's can lead to leaks.

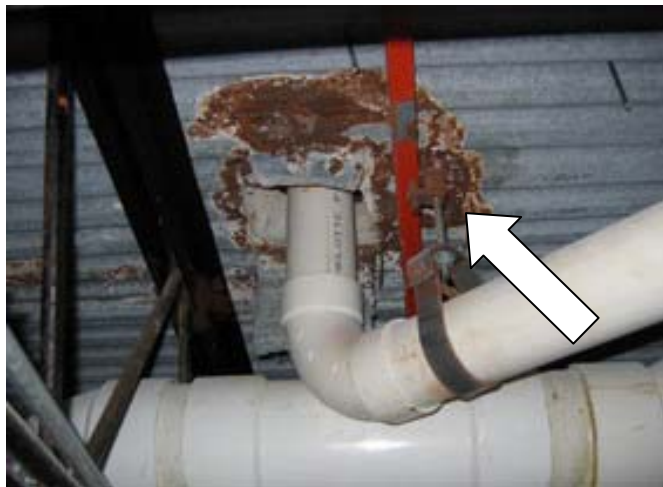
Photo # 5

- Corrosion was noted on several panels of roof decking above the suspended ceiling of the 2<sup>nd</sup> floor. This condition is usually attributable to roof leaks. The roof appears to be relatively new and the leaks were probably corrected when the new roof was installed. No defects were found in any of the roof membranes over this area. The deck should be monitored after a heavy rain for assurance.

Corrosion on the under side of the decking.

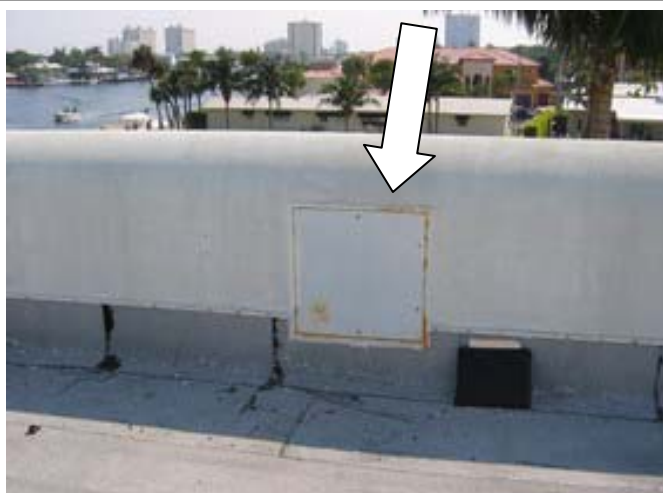
Photo # 6

- The parapet has six hinged access panels fabricated of sheet metal and latched with ¼ turn fasteners. There are no weather strips along the edges of these access doors and it is suspected that moisture can be driven through the edges of the panel openings during high winds and rain. It is recommended that the panels be either caulked or modified to accept some weather stripping to seal them.

The access panels are not water tight.

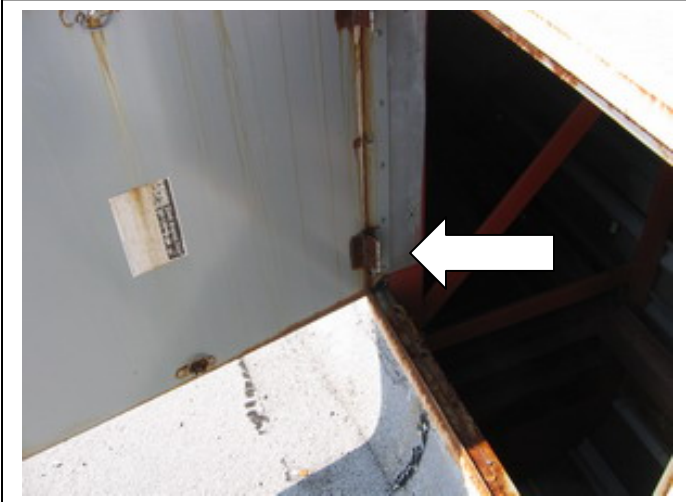
Photo # 7

The hinges on the access panels are corroded.

The hinges on these access panels are significantly corroded and need to be cleaned, repaired and lubricated to prevent further deterioration.

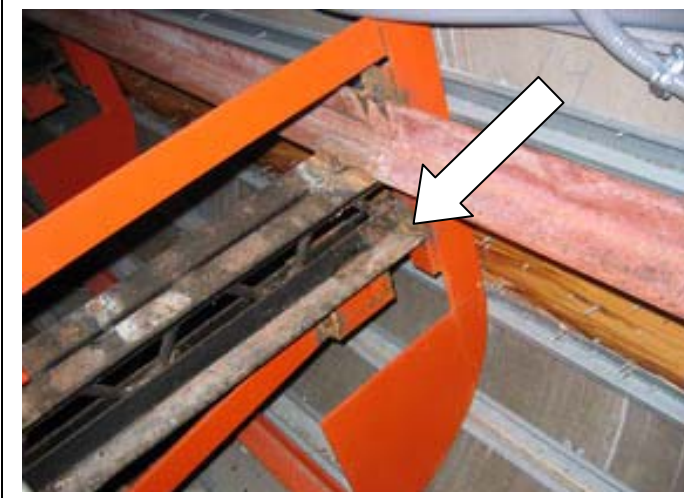
Photo # 8

Minor corrosion noted at the connection points of the roof joists inside the parapet cavity.

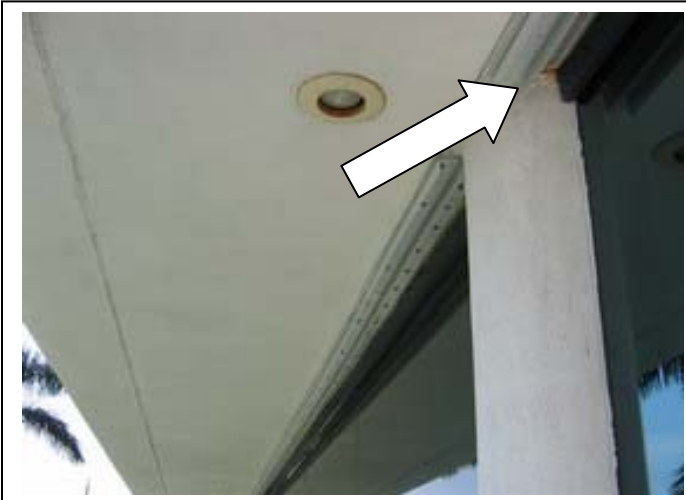
Photo # 9

- Corrosion was noted along an exterior trim strip above the rear balcony. This corrosion may be due to moisture inside the parapet walls. This strip should be monitored for further deterioration.

Corrosion in metal strip over east balcony may be forming from moisture penetration inside the parapet above.

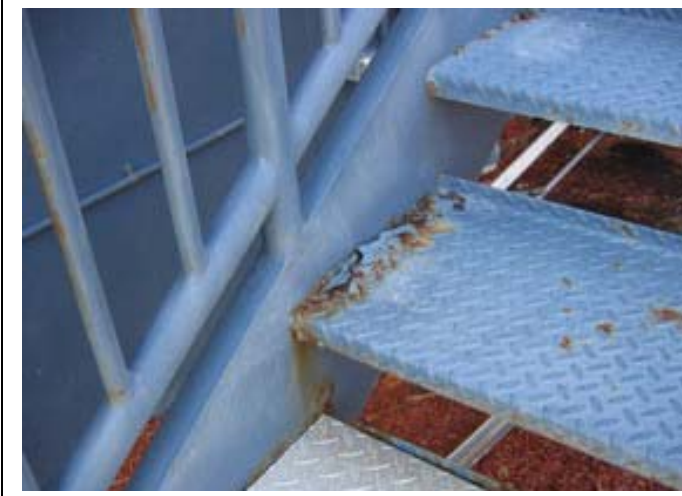
Photo # 10

- The exterior stairs are fabricated from ferrous materials that are exposed to the salt water environment. Significant corrosion has occurred on several of the connection points for the steps. The bottom step is missing and it is assumed that it corroded to an extent that it was removed. The safety of these stairs is questionable and it is recommended that a steel fabricator inspect them and make any necessary repairs.

Significant corrosion in several of the exterior stairs.

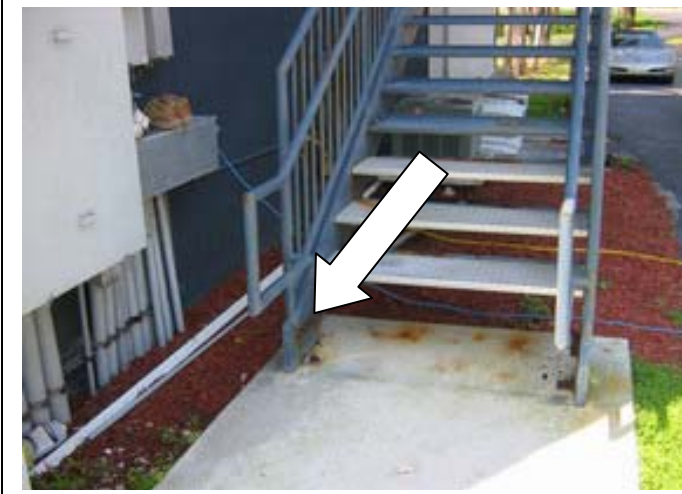
Photo # 11

Bottom step missing on exterior stairs. **This is a safety issue needing immediate attention.**

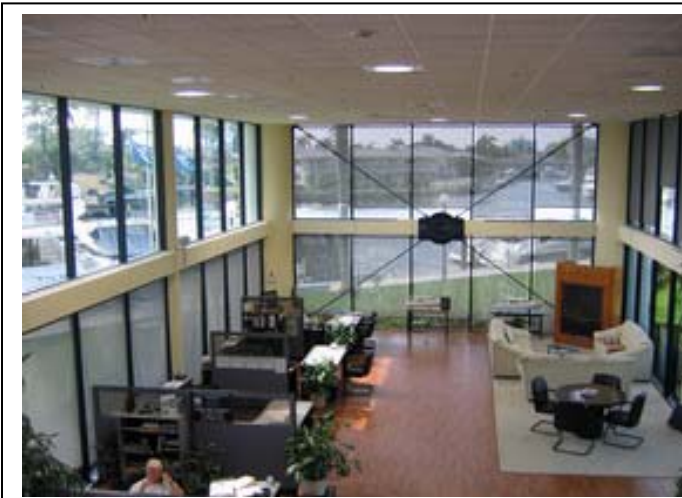
Photo # 12

The building's interior appears to be in excellent condition.

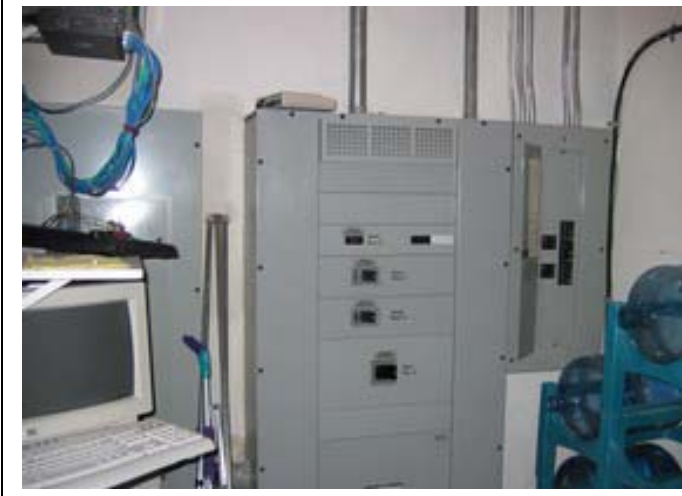
Photo # 13

The electrical system appears to have been professionally installed and in good condition.

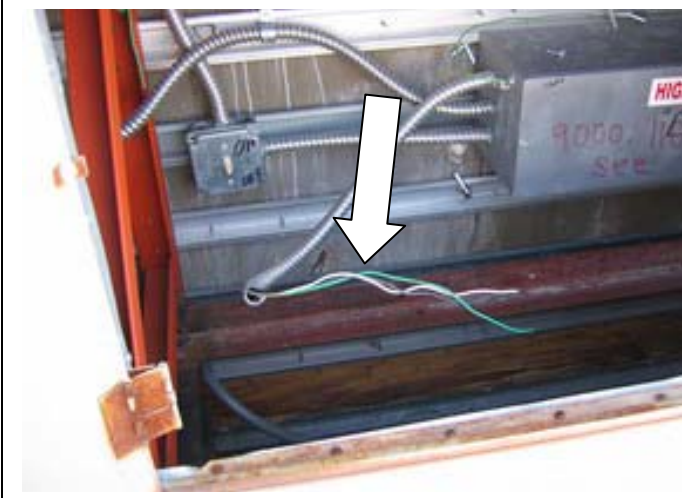
Photo # 14

**Electrical Systems** – All panels and wiring appear to have been professionally installed and in good condition. Some wiring inside the parapet walls needs the attention of an electrician. Exterior illuminated signs have been installed and the electrical work is untidy. Some abandoned circuits should be removed and secured.

Loose ends of wiring (inside the parapet) need to be cleaned up.

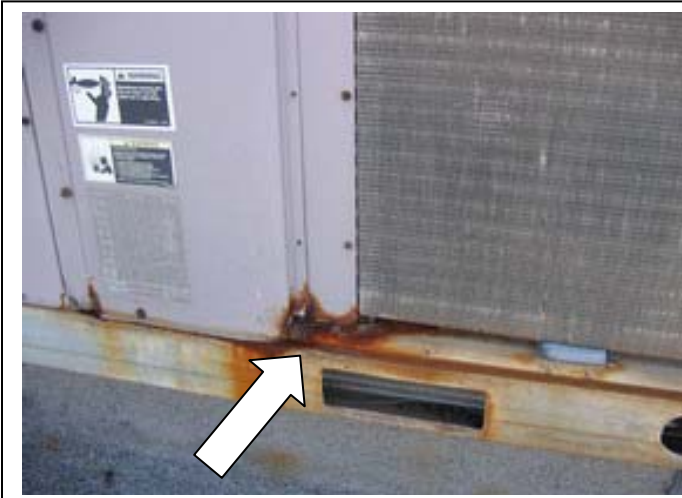
Photo # 15

- The condensing coils in the RTU's have a significant amount of corrosion but still appear to have adequate clear surface area to perform reasonably well. Commercial units typically last 10 years before repair cost and corrosion forces replacement. These units are nearing the condition to consider replacement within the next few years.

The RTU's have significant corrosion at some points.

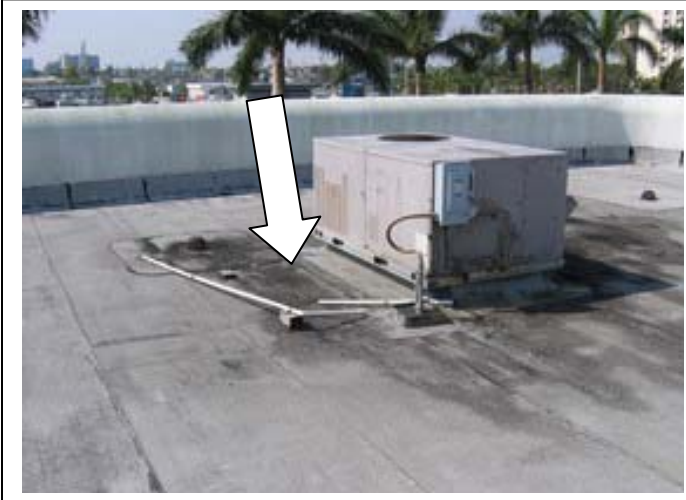
Photo # 16

- The condensate lines from the RTU's were at one time well managed on the roof to terminate into the roof drains near these units. This is a good design feature to keep the condensate off the roof surface. The condensate piping from the south unit is broken and needs to be repaired. The condensate is ponding around the curb opening and will contribute to an accelerated deterioration of the roofing materials in this area.

Broken condensate drain line on south RTU needs repair.

The discoloration surrounding this RTU is caused by ponding water. This can lead to accelerated deterioration of the roofing materials.

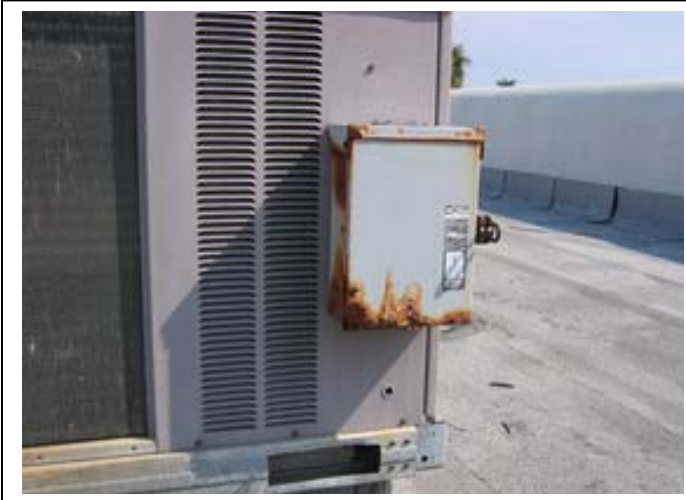
Photo # 17

- The electrical disconnect panels mounted on the RTU's are significantly corroded and are no longer water tight. Problems may occur if they are not replaced or repaired. They will need to be replaced if new units are installed.

Electrical panels on the RTU's are badly corroded.

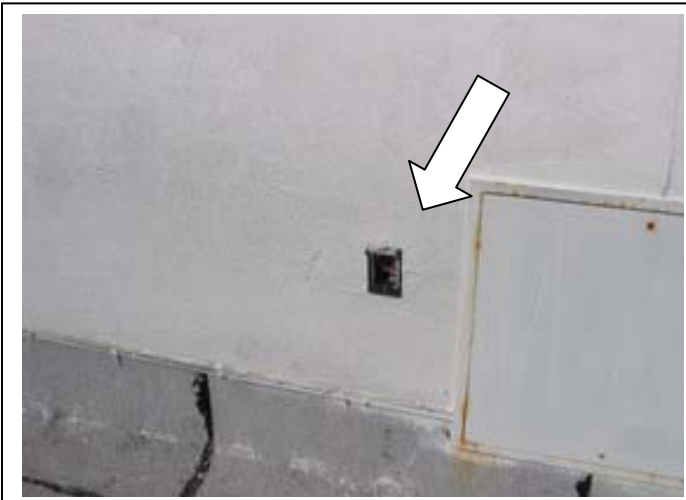
Photo # 18

Electrical junction box on parapet wall needs a cover.

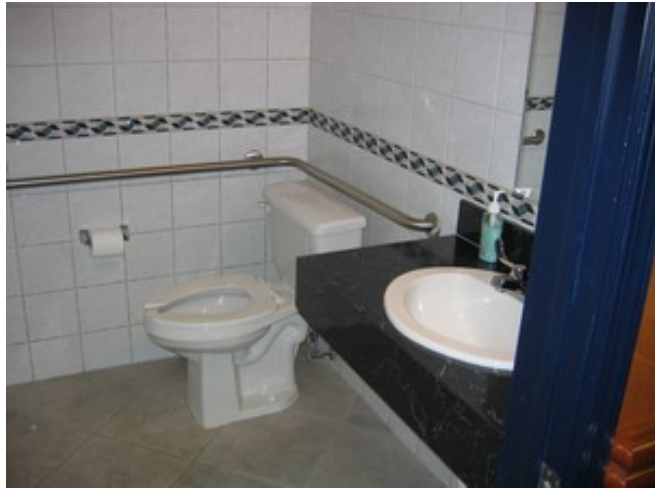
Photo # 19

The 1<sup>st</sup> floor restrooms appear to be ADA compliant.

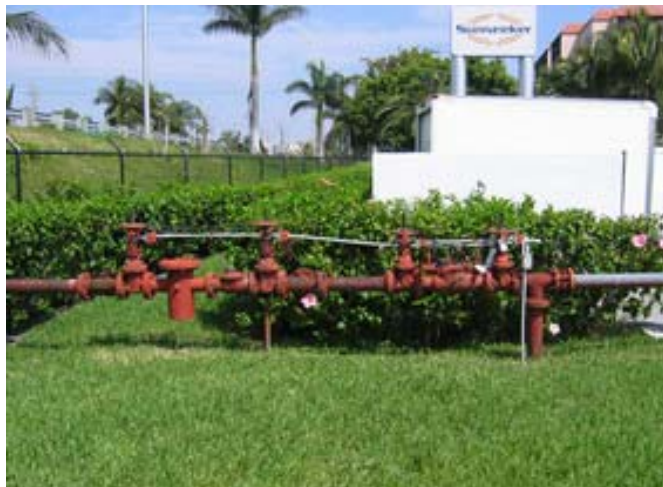
Photo # 20

There is a backflow prevention device at the SW corner of the site for the fire sprinkler system. This device needs to be inspected and certified annually by a licensed plumbing company. The last inspection sticker expires July 2005.

1. The fire extinguisher inspection tags expire in June 2005
2. The fire valve inspection tags expired in May 2004

Inspection tags need to be updated on the fire sprinkler valves and the backflow prevention device.

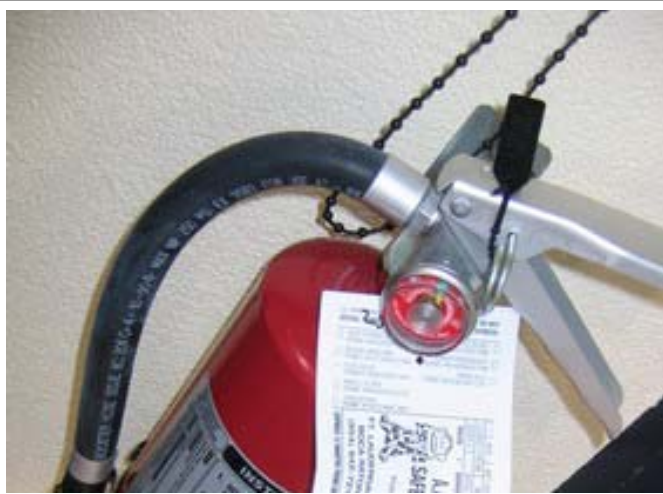
Photo # 21

Inspection tags on the fire extinguishers need to be updated.

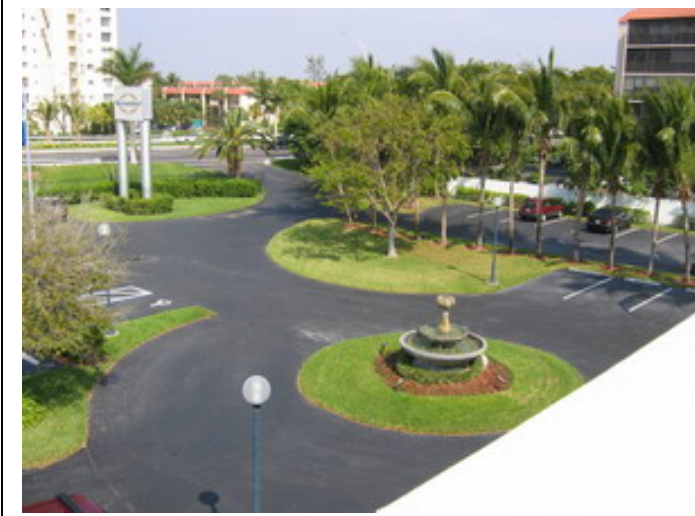
Photo # 22

The parking spaces, drives and landscape appear to be in good condition.

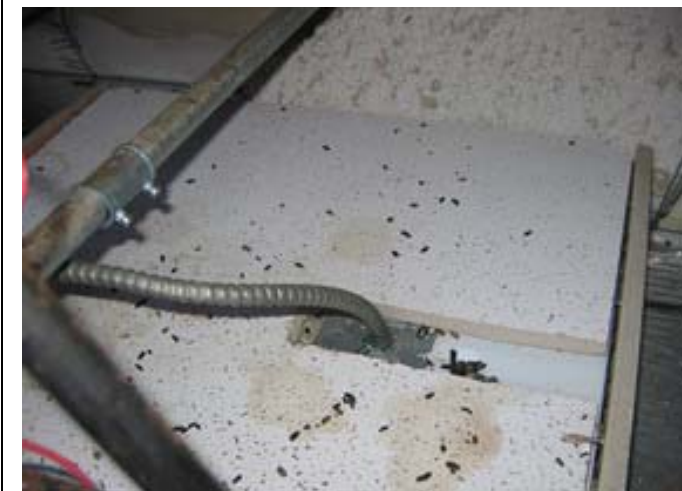
Photo # 23

**Wood Destroying Organisms** – There is no evidence of termite infestation or wood rot problems in the building. Small lizards have found access to the area above the 2<sup>nd</sup> floor ceiling. Their excrement was noted on the top of the suspended ceilings. Finding the access points and closing them off is the only remedy. No obvious entry points were noted. The lizards are not known to cause any damage.

Lizard excrement noted above the suspended ceiling on the 2<sup>nd</sup> floor.

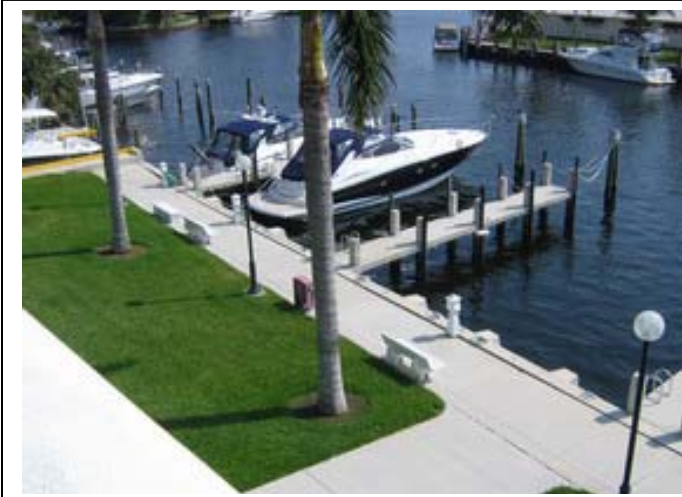
Photo # 24

The seawall was not inspected under this report.
