Roof Inspection Report

File Number: 05-15-RF-001

Client: Condominium Association of Subject Property

Type of Property: Five story condominium (59 units)

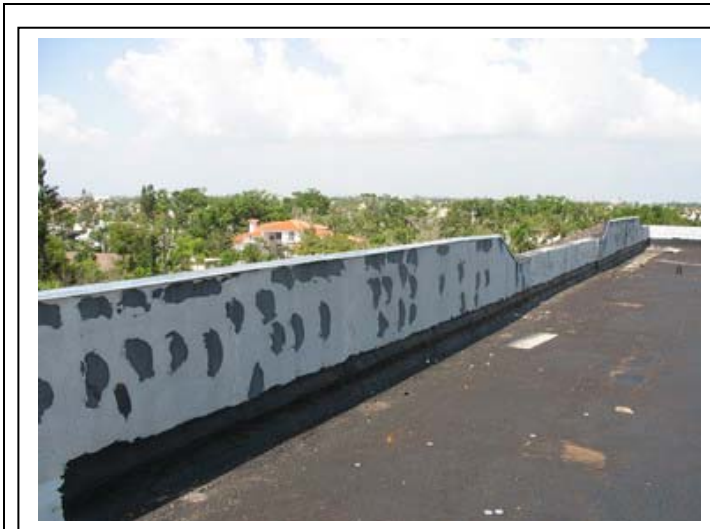
Photo # 1

- The flat section of the roof recently had a catastrophic failure at the SW corner of the building from hurricane Wilma. Winds were widely reported to be near 100 MPH during the storm and caused the roofing materials to lift and separate from the concrete deck. Future storm force winds in this range are likely and this old roof cannot be expected to withstand them.

Recently repaired area at SW corner of the roof. Uplift from hurricane Wilma severely damaged the roof.

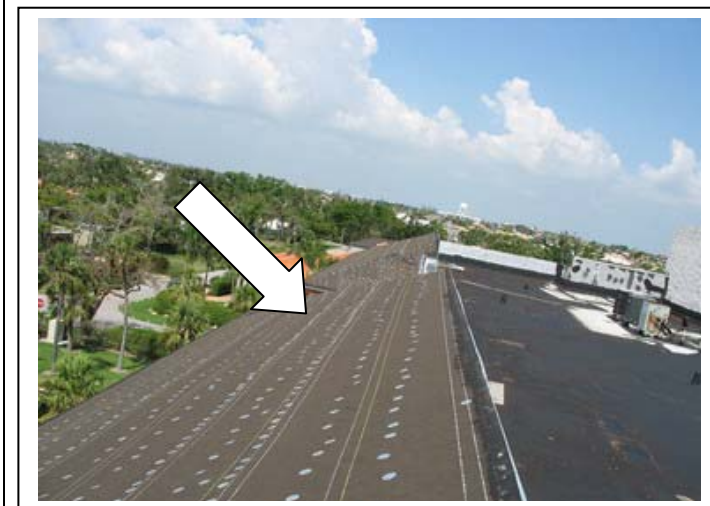
Photo # 2

Recent hurricane force winds damaged approximately 1800 SF of roofing materials on the SW corner of the subject property. The storm also damaged the roof tiles on the mansard that surrounds the roof. The condominium owners have an ongoing contract with a local roofing company to maintain the roof. Repairs on this 1800 SF area at the SW corner of the roof have been completed and the roof is currently thought to be in a water tight condition. The mansard sections have the base sheets of rolled roofing materials nailed in place. Cap sheets and roofing tiles have not yet been applied to the mansard sections. The workmanship of the recent repairs appears to have been performed at typical industry standards.

Mansard sections of the roof are in process of being repaired.

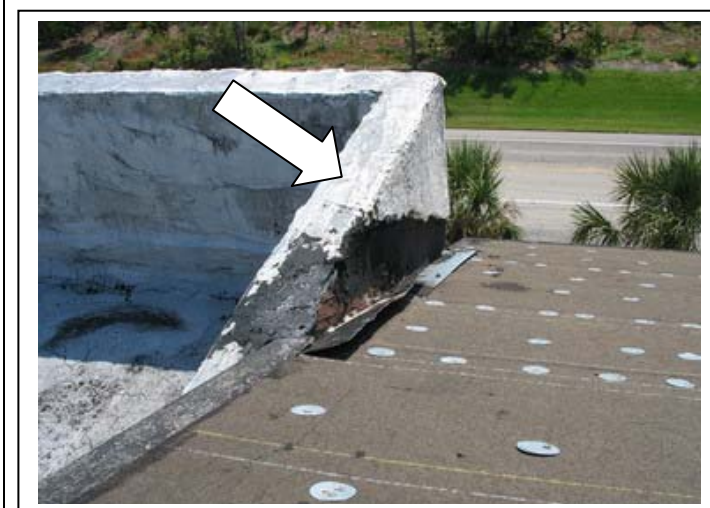
Photo # 3

Coping caps should be added to existing parapet walls.

- Coping caps should be installed on all parapet walls. Coping caps prevent water penetration through the top of the block walls. Some walls currently do not have caps. Waterproofing materials applied to these walls are cracking.

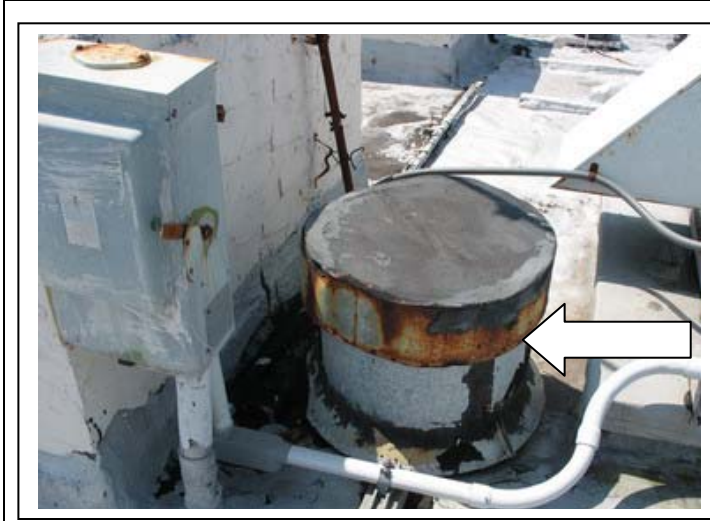
Photo # 4

Corroded sheet metal needs to be replaced.

- Many sheet metal vents and rain caps over roof penetrations are corroding. All sheet metal should be replaced with a new roof.

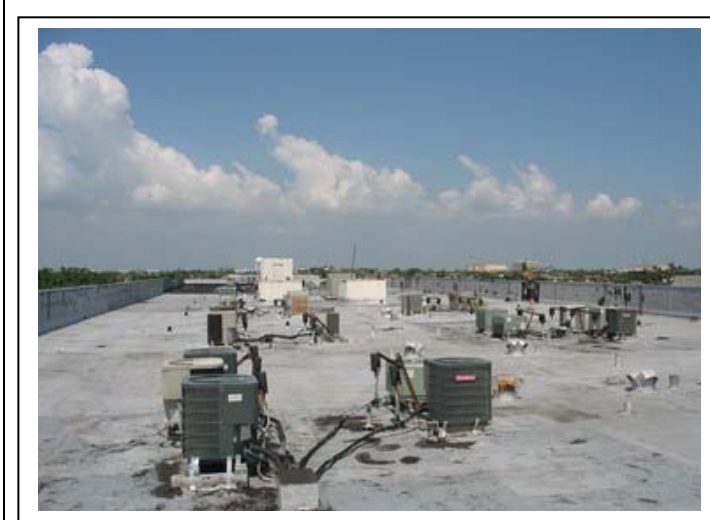
Photo # 5

- There are approximately 65 condensing units on the roof for air conditioning systems. Current building code requires that any replacement unit be raised on a stand that is attached to the structure and designed to withstand hurricane force winds. All of the condensing units on the roof are currently mounted to wood blocks that are bonded to the roofing materials. Hurricane force winds push against the units and can cause tears in the roofing materials surrounding them.

All mechanical equipment needs to be raised off the roof with stands.

- All mechanical equipment will need to be raised and placed on stands. This will add a significant cost to the project but must be done to comply with the new building code.
- The roof is five stories high. This complicates material removal and replacement and adds cost.

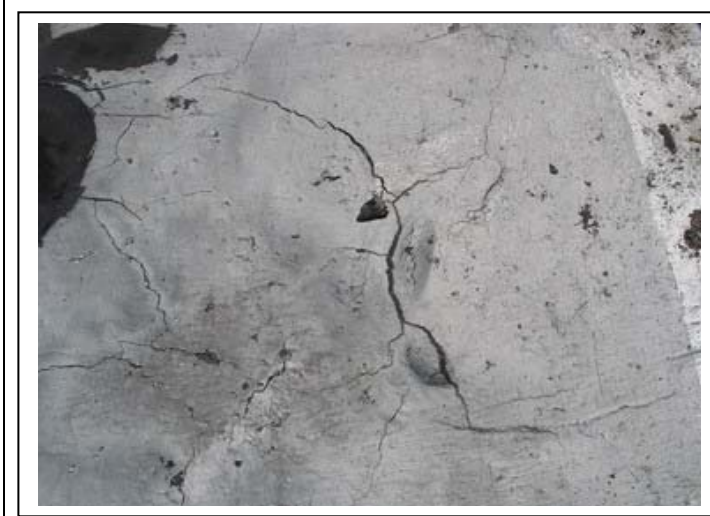
Photo # 6

- The surface materials on the flat sections of the roof are brittle from old age. These materials are approximately 30 years old. The original materials had a typical life expectancy of 15-20 years. Roofing materials that have lost their elasticity are susceptible to leaks from foot traffic, and stress from normal thermal contraction and expansion.

- Failures of roofing materials caused by uplift can allow water to penetrate and travel between the concrete deck and the roofing materials and become trapped. Heat from the sun will cause this trapped moisture to form gas blisters and splits in the water proofing materials. This process self-perpetuates by causing more openings for water penetration.

Blisters and cracks in the brittle roofing materials are widespread.

Replacement of the entire roof should be considered. This roof has far exceeded its expected reliable service life.

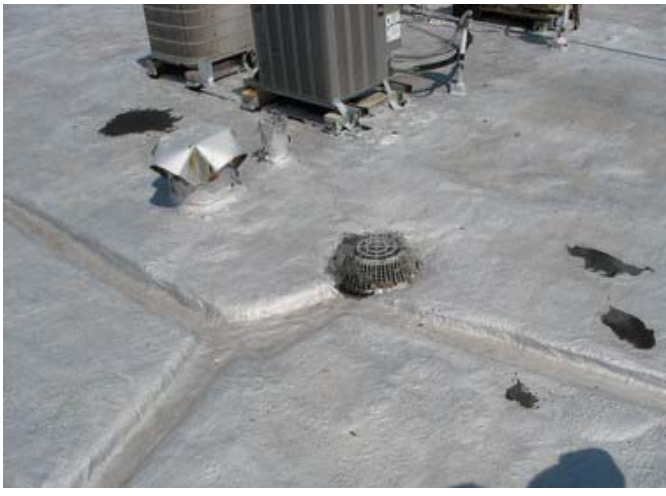
Photo # 7

- Channels are not typically found in well designed roofs. With a good roof design they are not needed. These were likely added to compensate for lack of adequate slope in the original roof design. Adequate slope is needed to move the water off the roof and allow it to dry between rains. Ponds of standing water on a roof caused by lack of proper pitch break down the roofing materials and prematurely age them.
- There are numerous patches throughout the roof. This indicates that past repairs have been frequent, numerous and likely costly.

Channels in the roofing materials are not needed if the roof is properly sloped with tapered insulation.

- The roof has many extra layers of added material from years of patching. This will add additional costs for removal.
- New tapered insulation should be included in the specifications to provide adequate slope to drain towards the roof drains. The amount of pitch should be shown on a roofing plan that is part of the contract.

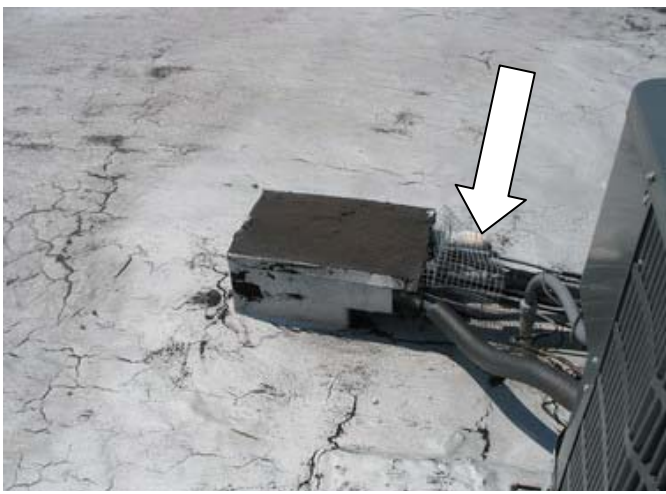
Photo # 8

New roof penetrations for refrigeration lines and electrical connections to mechanical equipment need to be designed before the roof work begins.
