Roof Inspection Summary Report

File Number: 05-15-RF-002

Inspector: Craig Milliken, PE
CPM Real Estate Inspections, Inc.

Date of Inspection: 02/26/04

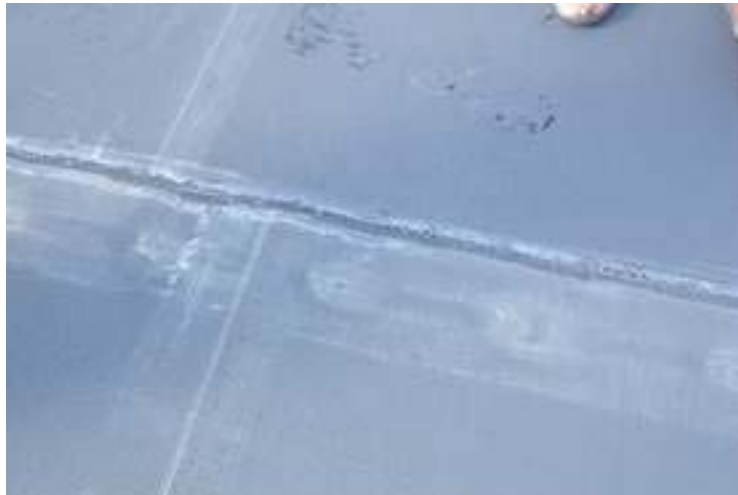
Overall the roof appears to be in good condition and professionally installed.

Large sheets of the EPDM membrane are welded together at the seams. All of the seams appear to be well bonded and it is unlikely that any current leaks are attributed to holes in the membrane.

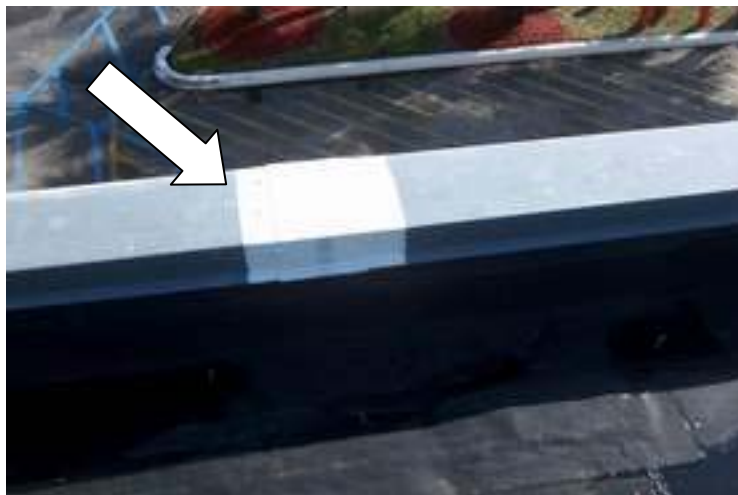
Patches by the roofing company have been placed over joints in the parapet cap. These joints need this type of maintenance to keep them water tight.

This is a typical repair that was professionally performed by Crowther Roofing personnel.

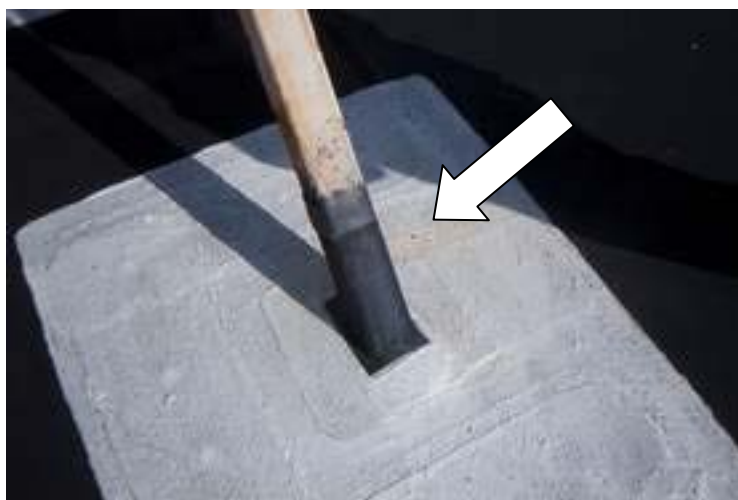
These are also typical repairs made by the roofing company.

This area around this support brace could have had leaks but is now water tight

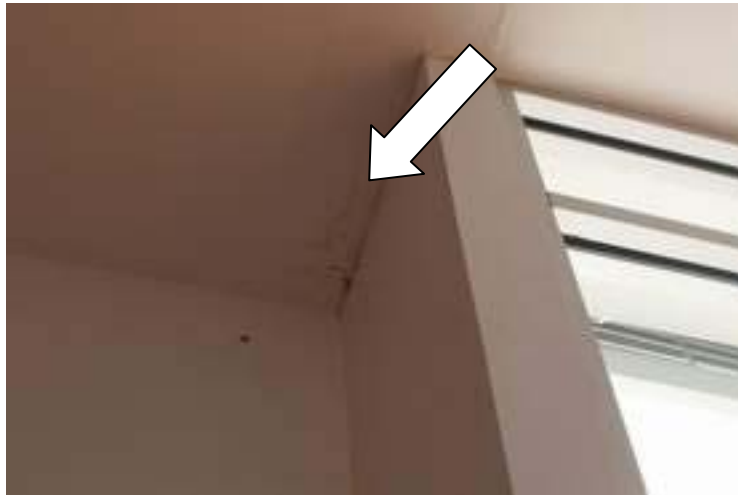
Water stains such as this one near the front entrance are probably attributed to roof leaks from the kinds of problems noted above

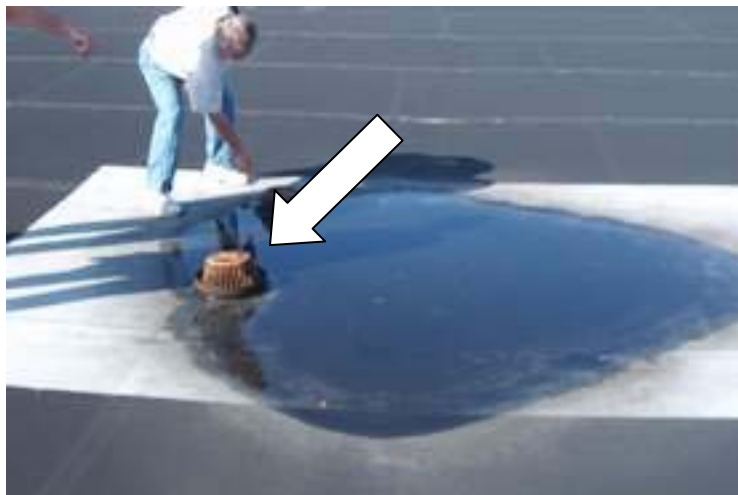
The ponds are a result of improper sloping of roofing materials, during the original installation of the roof, around the drains. These areas unfortunately cannot be reworked without removing a significant portion of the roof around each drain with this problem. The most cost effective solution to address this issue is to monitor each area and to reseal any de-lamination or cracking of the roof membrane as they may appear.

The area around this roof drain is not sloped properly to allow for proper draining. This standing water can cause an acceleration of the deterioration of the roof membrane.

The white square is a patch that has been applied by Crowther roofing personnel to prevent this deterioration.

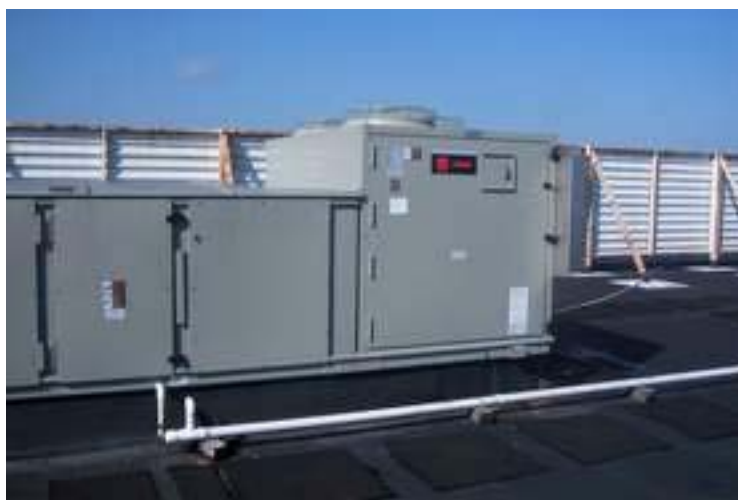
This is one of six air conditioning units mounted near the center of the roof.

Four of them are only a year old but two are original equipment from 1991. All of the RTU's on the roof were professionally installed.

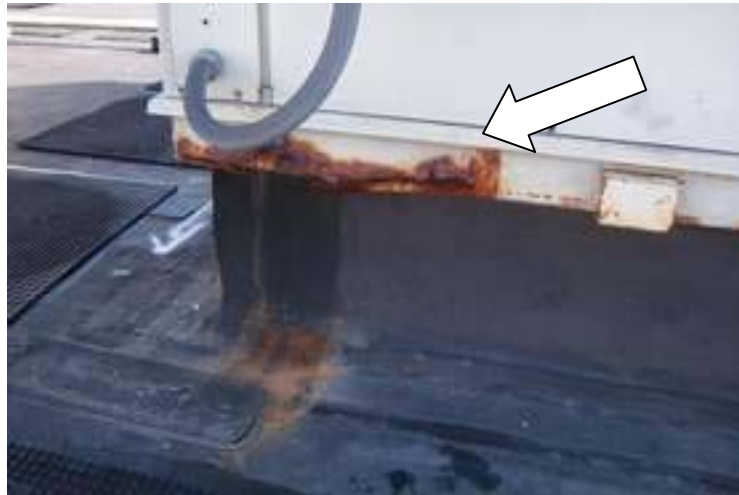
Several leaks were noted in the ceiling areas around the two older package units. During this inspection these older units were opened and inspected. A significant amount of corrosion was noted in the bottom of these two units and in the sheet metal frames and interior panels of these units.

This is the corner of one of the older units. The frame is rusted and could be a source of the current leaks. Water can get through this rusted area and fall down inside the curbing on which this unit rests.

If the two remaining 1991 package units are replaced, the potential of water leaking through these units will be eliminated. When they are removed, the curbing under these units can be inspected and any problems addressed. Attempting to repair or seal any leaks in these two older units will probably not be effective or provide a lasting remedy.

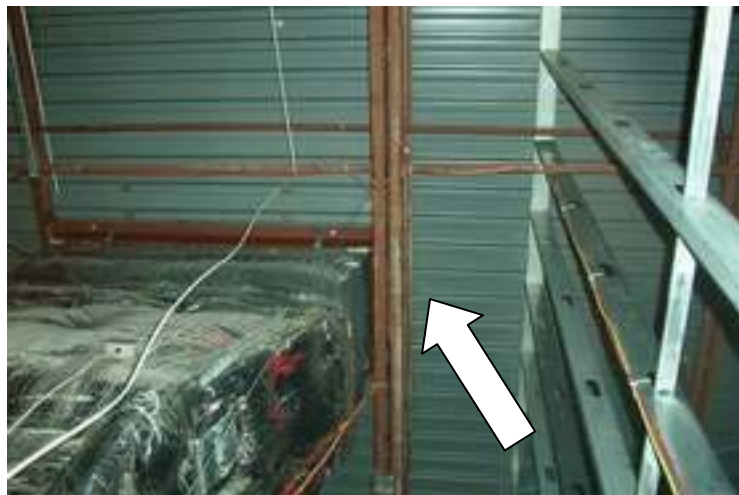
This is the ductwork that runs under the older unit that is located above the Young Men's Clothing area in the store. Water was running down from this area in significant quantities.

The ceiling is too high to safely inspect closely without a lift and removing a significant portion of the ceiling

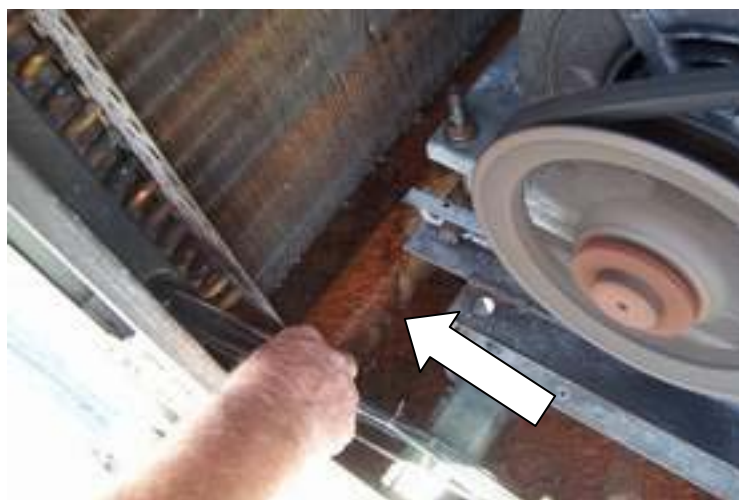
These units could not be safely accessed from the sales floor below to positively identify the exact points where the water was originating from; however, it is likely that the current active moisture problems noted in the ceilings of this building are due to water from rain and condensate leaking through these two older units. It is recommended that these two original RTU air conditioning units be replaced because of their age and because water was observed dripping from under areas where these units are located on the roof. These units are identified as unit

The interiors of the two older air conditioning units are heavily corroded.

It is likely that water is leaking from under them down into the building

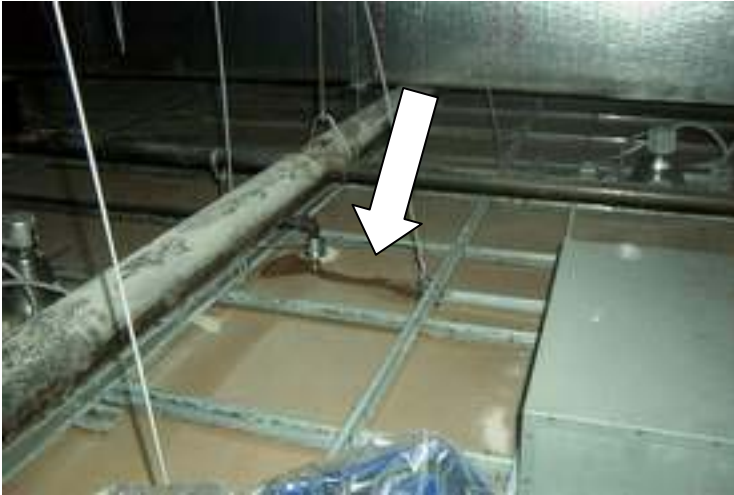
It was noted above the Jewelry area that the dripping water seemed to be coming from a section of the roof just north of unit # 3. There is suspicion that water may be trapped under the roof membrane in this area. It is suggested that this area be opened and examined. If water is found in this area it should be removed and the roof membrane resealed. Ron Ricketts is estimating the cost to perform this invasive examination.

This area just north of the jewelry department has an active leak.

This is the area where trapped water may be under the roof membrane.

Crowther roofing personnel need to cut open the roof and determine if this is what has happened.
