## Roof Inspection Summary Report

**File Number:** 05-15-RF-004

**Date of Inspection:** 11/25/2005

A visual inspection of the subject property was performed on Friday, November 25, 2005 at 8:30 AM. This Roof Inspection Report addresses the probable causes of water intrusion throughout the temple.

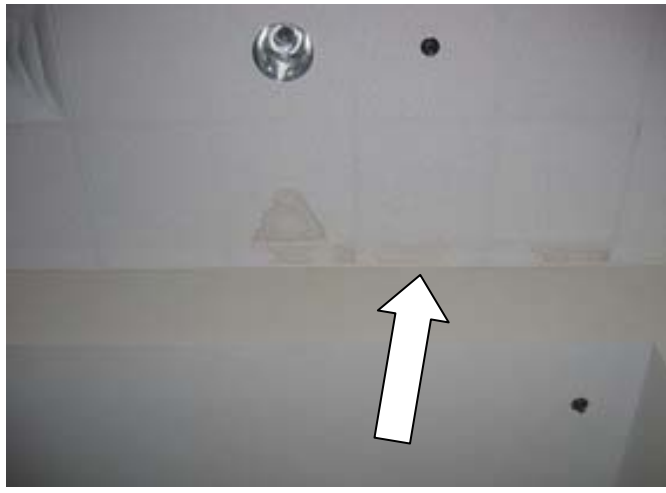
Photo # 1

There are numerous stains along the perimeter walls and ceilings near these walls.

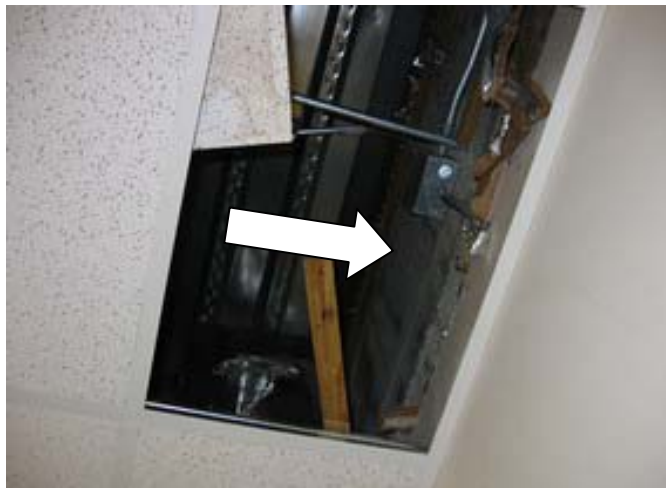
Photo # 2

Water stains appear on the interior side of many interior concrete walls.

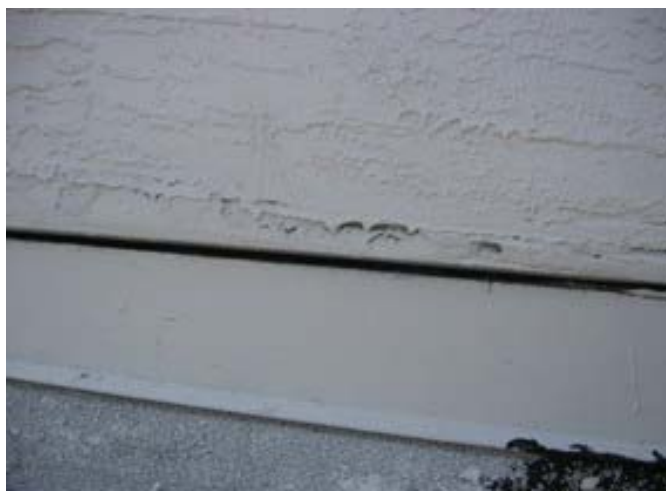
Photo # 3

All materials and workmanship appears to be good at the base of the parapet walls. It is doubtful that water is getting in at these points where the roof and parapet walls meet.

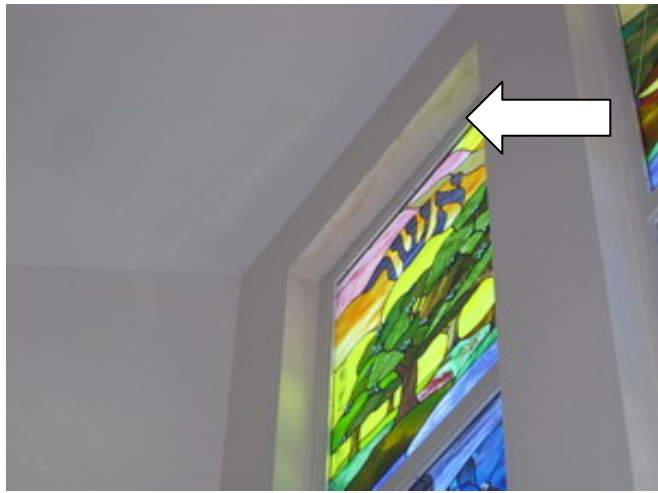
Photo # 4

Water could be entering through caulking around the windows but the leaks are likely not from problems with the caulking or windows.

The moisture appears to be coming from above. It is suspected that this moisture is entering the top of the parapet wall above.

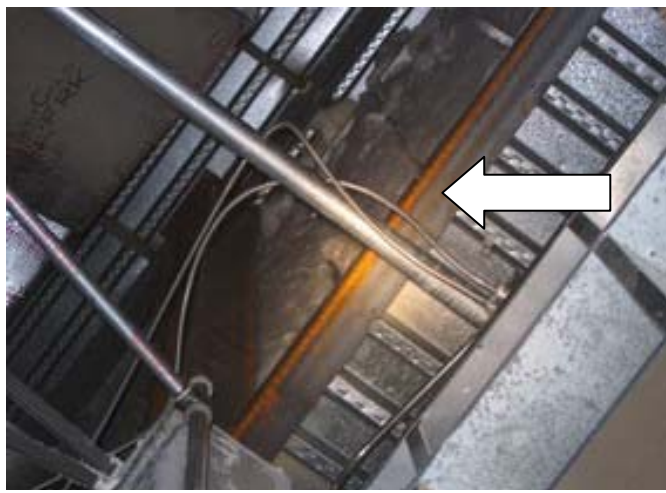
Photo # 5

Rust on steel under the roof indicates roof leaks.

Stains in ceilings not near exterior walls are probably due to incorrectly installed curbed openings and roof penetrations for the electrical connections to the RTU's.

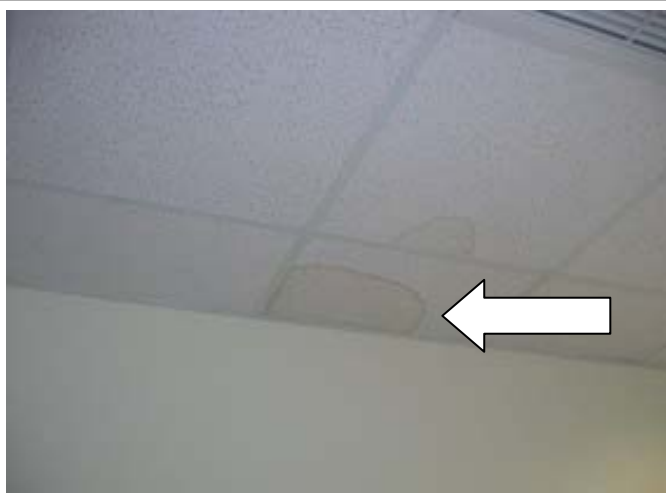
Photo # 6

This stain in the office area is directly under a RTU. These are recent stains that occurred last week after a heavy rain.

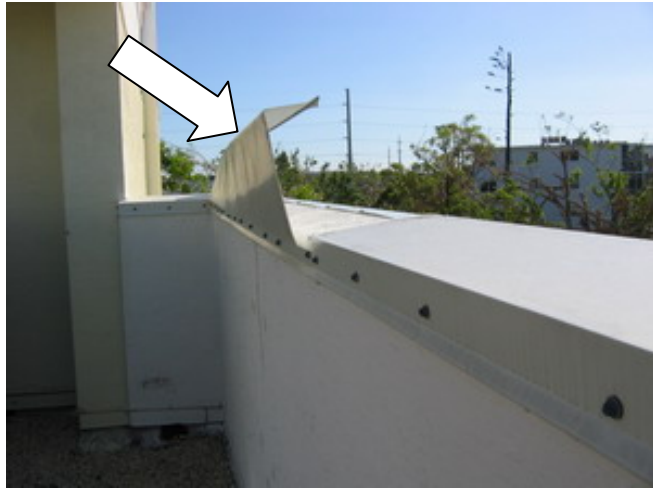
Photo # 7

- There is no indication of damage to the building or roof from recent hurricane force winds except for a damaged 10 foot long section of parapet cap along the south side of the building. See photo # 7. Stone ballast is not displaced and lap joints appear to be secure throughout the roof.
- There is no indication of neglect or improper maintenance by the owners.

One section of parapet cap was damaged by hurricane Wilma. This is the only damage noted due to the hurricane.

This section of parapet cap needs immediate replacement.

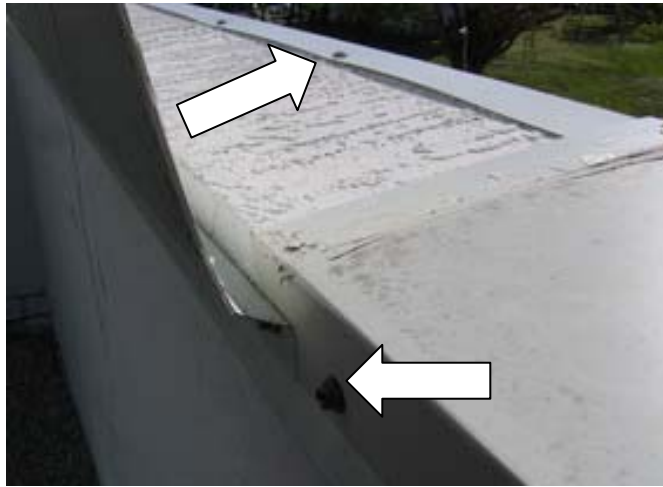
Photo # 8

The metal parapet cap is constructed of two sections. There is a metal drip edge under the coping cap that is screwed down into the top of the parapet walls and hangs over the outside edge of the parapet walls. Tapcon screws anchor the parapet cap over the drip edge to the roof side of the parapet walls. Screw holes for both sections are approximately 12 inches on center and may allow water to penetrate the block wall cavity and find passages to the building's interior walls below. See photos # 7 & 8.

The exterior drip edge (upper arrow) is held down under the parapet cap with screws. Drilling into a parapet is not a good practice unless the screw holes are thoroughly sealed. They are not.

All screw holes and the joints between the sections should be sealed with a suitable caulking material. Only A Roofing Contractor or Water Proofing contractor that is familiar with this type of coping cap assembly should perform this work.

Water can leak through the drill holes for the screws. All of the parapet caps need to be reworked.

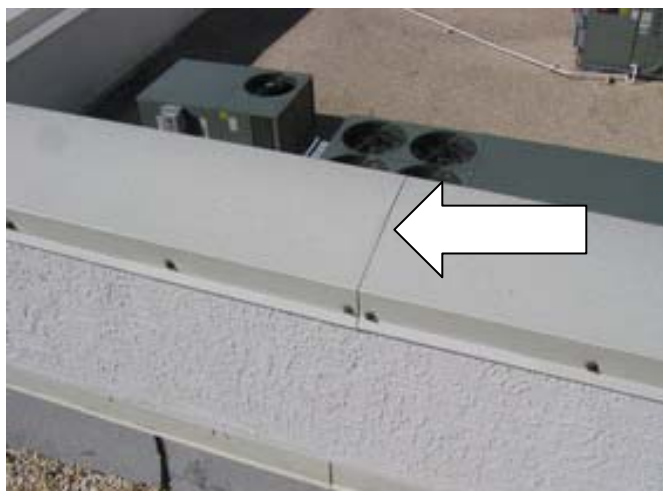
Photo # 9

The installation of the parapet cap was not done correctly to ensure that all screw holes were completely sealed and that the joints between sections were sealed. Water can easily penetrate under the coping cap at these joints and penetrate the screw holes holding down the drip edge or cracks in the stucco covering the top of the parapet walls. See photo # 9.

Most of the joints between the cap sections are not caulked. Water entering at these joints can find its way inside the building through screw holes and cracks in the stucco under the cap.

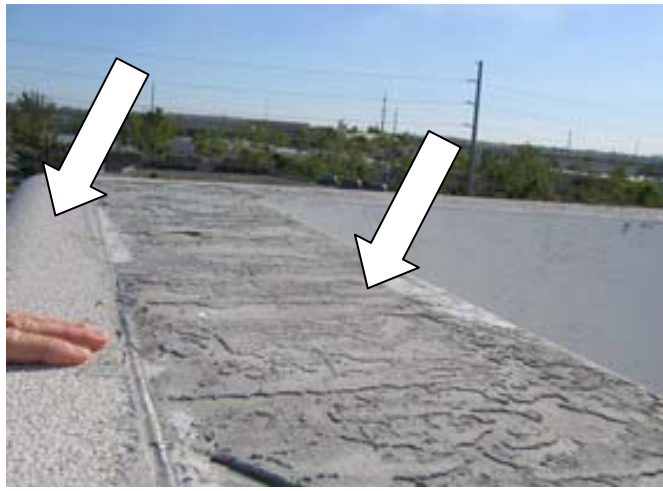
Photo # 10

The parapet wall over the east end of the temple has no metal cap. The position of the architectural relief (left arrow) makes it difficult to fit a cap over both. Some kind of cap needs to be fabricated. Sealants applied over the top surface of a parapet typically shrink, crack or in other ways fail over a short time. Metal caps properly installed will last.

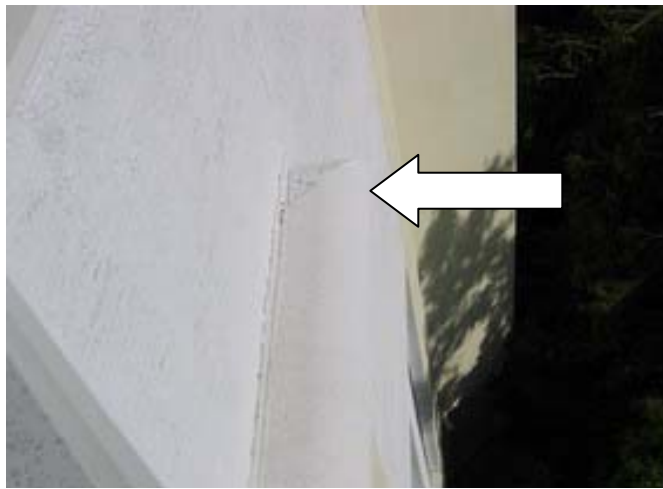
Photo # 11

There are gaps in the joints of the architectural reliefs over the windows. It is possible that water could penetrate any small opening in the wall behind the relief. If screws or mounting posts were drilled to support the reliefs they should have been sealed.

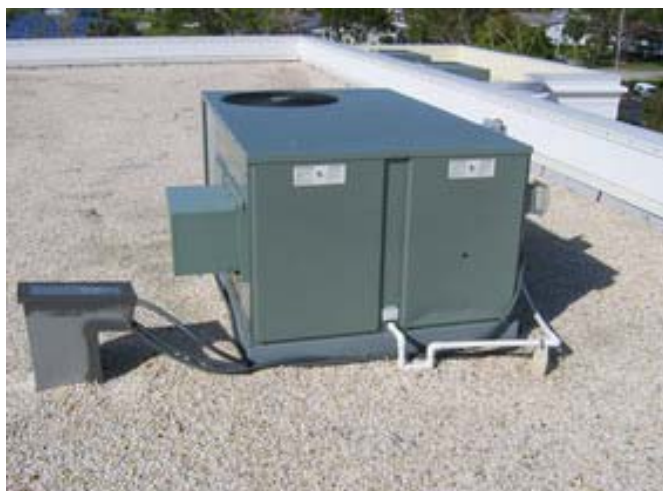
Photo # 12

RTU's are supposed to be installed on curbs a minimum of 8" above the surface of the roof. This one is sitting nearly flush with the roof surface.

If the roof floods around the base of these units during a rain the opening under the RTU can leak.

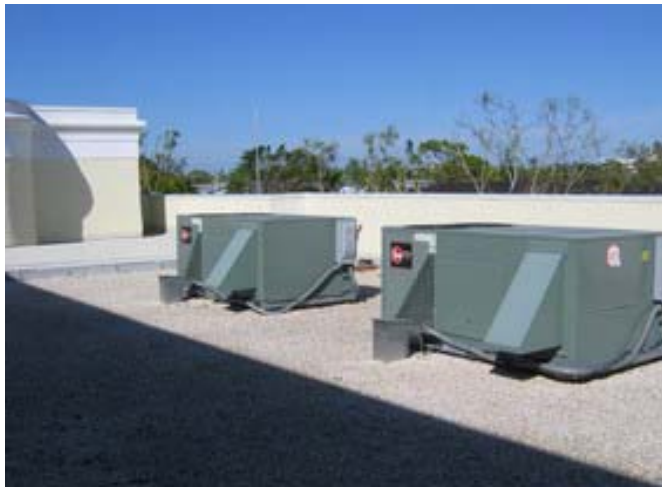
Photo # 13

Most of the units are not elevated correctly or level. This is unusual to find in a new building. Why it happened is uncertain.

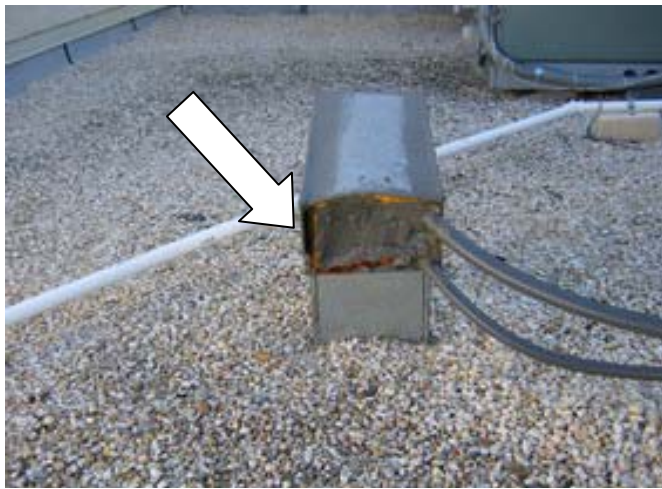
Photo # 14

These are not well designed. The open face should point down toward the roof and not face horizontally.

Shrouds for roof penetrations near the RTU's need to be filled with additional foam sealant to close gaps caused by shrinkage.

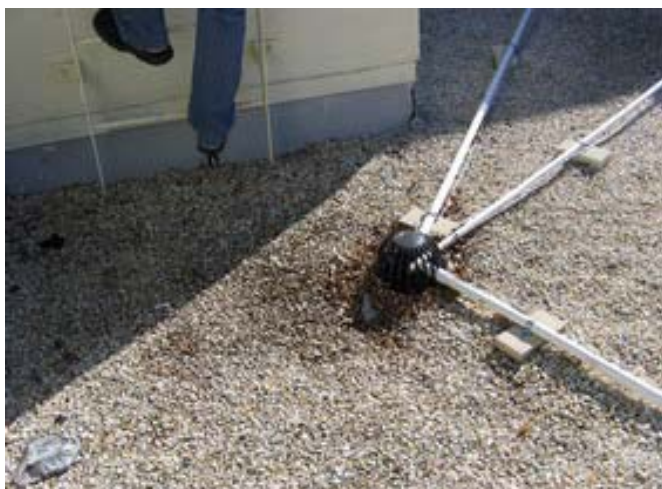
Photo # 15

Condensate drain lines are properly routed to roof drains but they are not correctly secured to the roof as required by the 2001 building code.

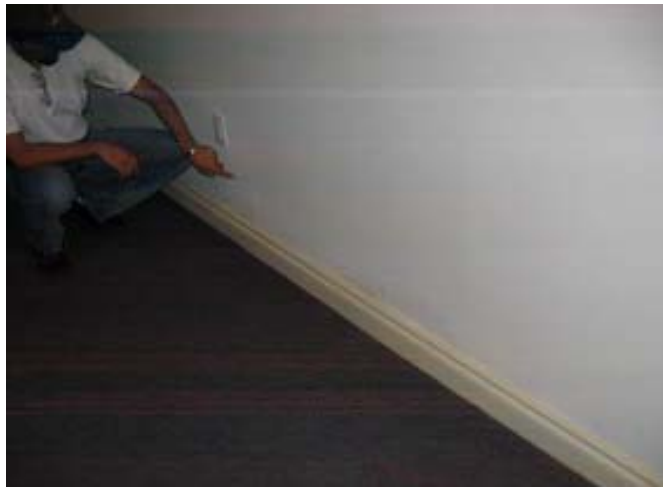
Photo # 16

Water damage to the interior walls is extensive in some areas because these problems have not been quickly addressed. Test samples of these materials would likely find mold growing in these chronically damp areas.

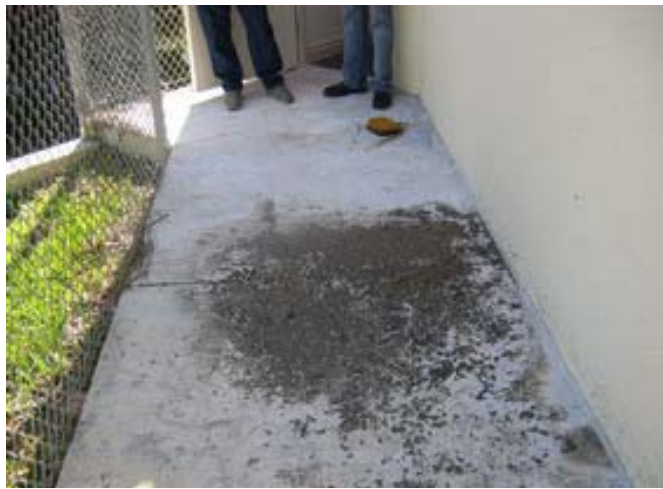
Photo # 17

During the inspection it was noted that there was a gap in the weather stripping around an exterior door at the NE corner of the building and a section of walkway outside the door where water is ponding due to insufficient pitch. These items are noted in photos # 17 & 18. Items such as these were not the focus of this inspection. A more comprehensive inspection may reveal other similar deficiencies.

Roof run-off accumulates on this walkway (NE corner of building) that is not pitched properly to drain. In rainy weather slime grows in this "Bird Bath" and creates a slip and fall hazard.

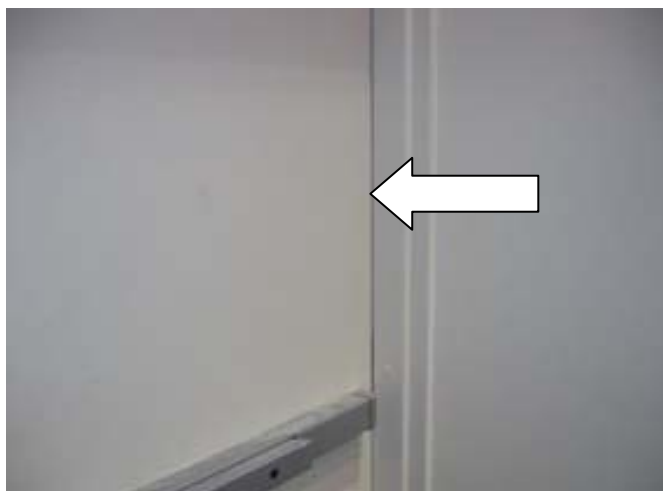
Photo # 18

The weather stripping in this emergency exit door (NE corner of building) does not seal properly.

Rainwater entered during the recent hurricane.
