Roof Inspection Report

File Number: 05-15-RF-005

Type of Property: Single Family Home

Date of Inspection: 04/04/2006

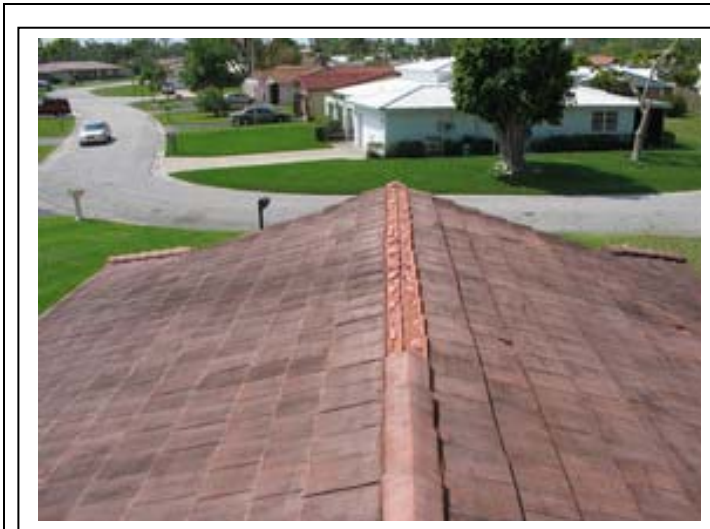
Photo # 1

- All ridge tiles are loose and many are missing. Tiles throughout the fields of the roof are cracked and loose. The sagging of the roof is a cosmetic issue; however these two areas cannot be realigned without removal of a significant portion of the roof sheathing to access the trusses. It is recommended that a new roof be considered instead of repairing the damage. A general contractor should be consulted prior to soliciting bids for a new roof. Most roofing contractors do not have the qualifications to make modifications to the trusses. A general contractor can determine how much of the roof sheathing needs to be removed to find all structural elements needing repair, further bracing and shimming to align the roof surface. Adding new roofing materials without first performing these steps will not produce adequate results.

Ridge tiles are missing and those that remain in place are loose.

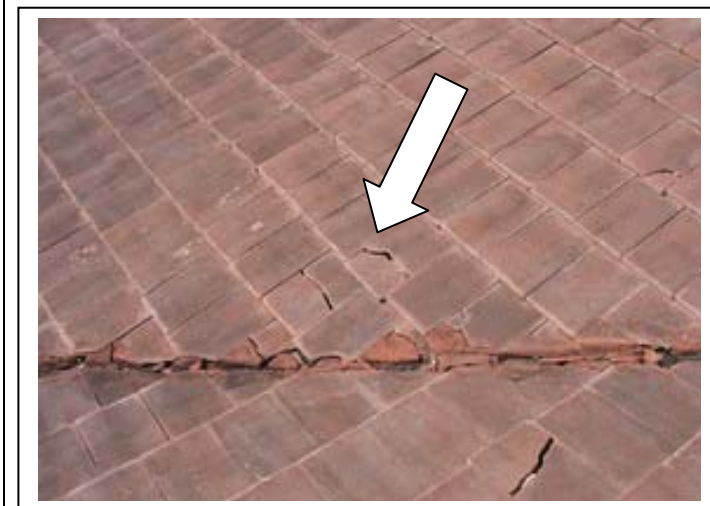
Photo # 2

There are many cracked tiles in the fields and valleys of the roof.

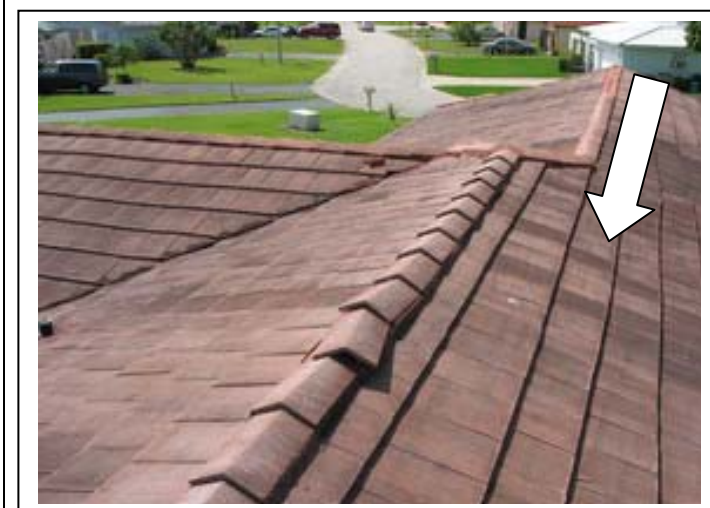
Photo # 3

1. The cause of the sagging sections of the roof appears to be due to poor design and workmanship in the structure of the roof.

The roof is sagging over the kitchen area.

Hurricane force winds may be a contributing factor in creating the sags in the roof in these two areas; however, some structural elements were not installed properly and were weaker than the other trusses throughout the roof. The roof trusses in these areas will need to be repaired when a new roof is installed. It is recommended that a general contractor be consulted prior to any new roofing work to correct these structural problem areas. These repairs can only be made by removing the roof tiles and sheathing over these areas.

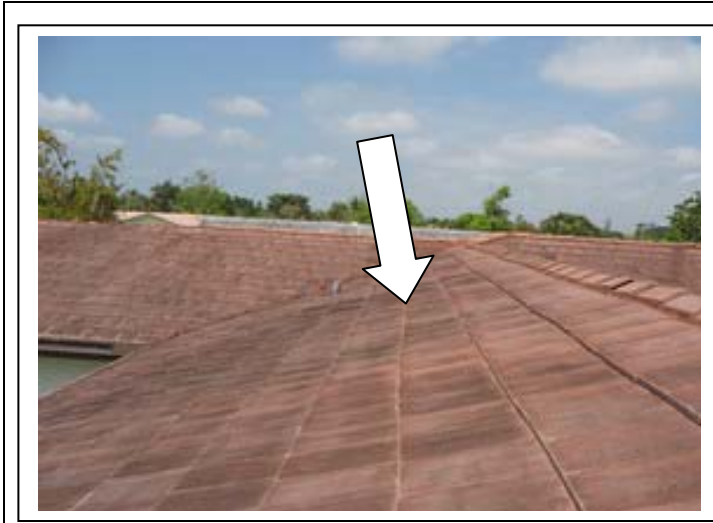
Photo # 4
The roof is also sagging over the living room. This field faces south.

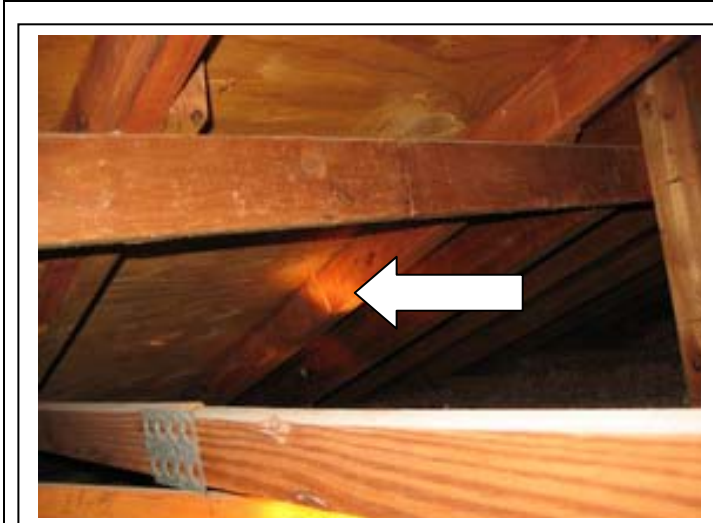
- The top chords of two trusses supporting the roof over the kitchen area are cut and spliced. The splices are likely the contributing factor in the weakness of the roof in this area and the hurricane force winds may have loaded this area and caused the sagging.
- A brace and loose shim was noted under the sagging roof section over the living room. This area of the roof was inaccessible through the attic because of the low pitch of the roof and lack of adequate clearance to safely maneuver. It is likely that splices were placed in this section of the roof as well.

Photo # 5
Top chord of truss over the kitchen area is cut and spliced.

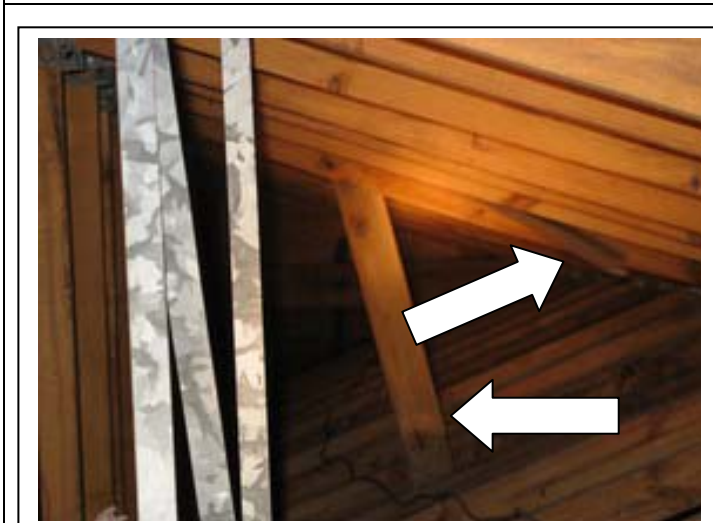
Photo # 6
Brace and loose shim under roof over the living room area.

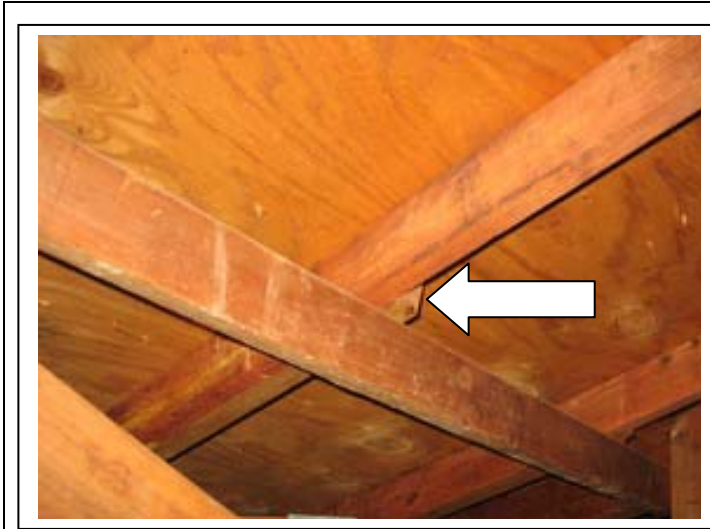
Photo # 7

Additional splice south of the area shown in photo # 5.

These splices need to be reworked by a general contractor after opening the surface of the roof to gain access to find all of them.

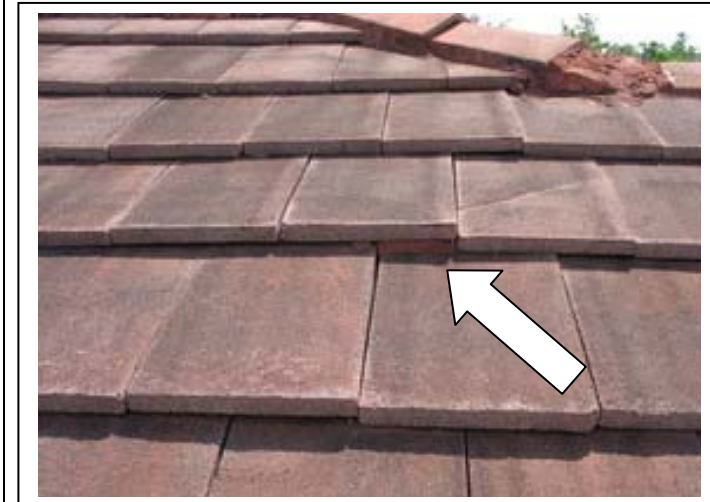
Photo # 8

Mortar tucked under a tile over the kitchen area indicates that the roofer in 1994 attempted to compensate for the sag in the roof over the kitchen area. The problem with the roof likely started when the home was constructed.

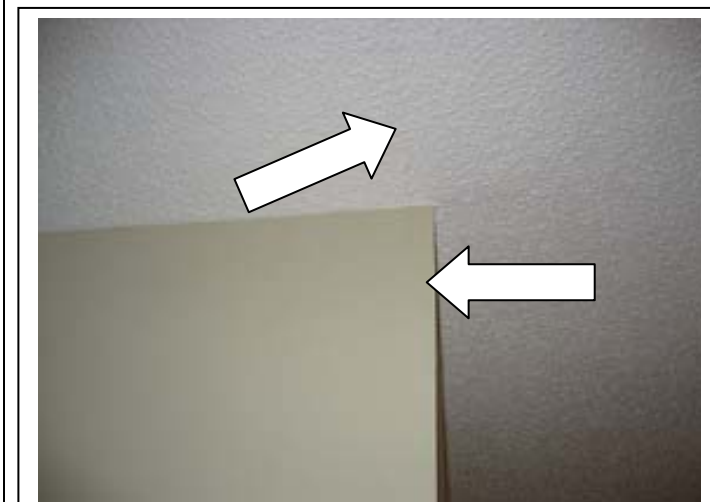
Photo # 9

- These appear to be hairline cracks that are similar to those found in most homes due to normal settling of the foundation or structure. Trauma from hurricane force winds can cause the entire structure to shake and settle. The cracks are less than 1/32 of an inch wide and show no offset displacement. There is no indication of any foundation settling. The sagging of the roof over the kitchen and living room may have transferred some stress to the framing of the walls and ceiling; however these elements appear stable and secure at this time.

Hairline cracks in the ceiling and wall of the living room area can be covered with paint.

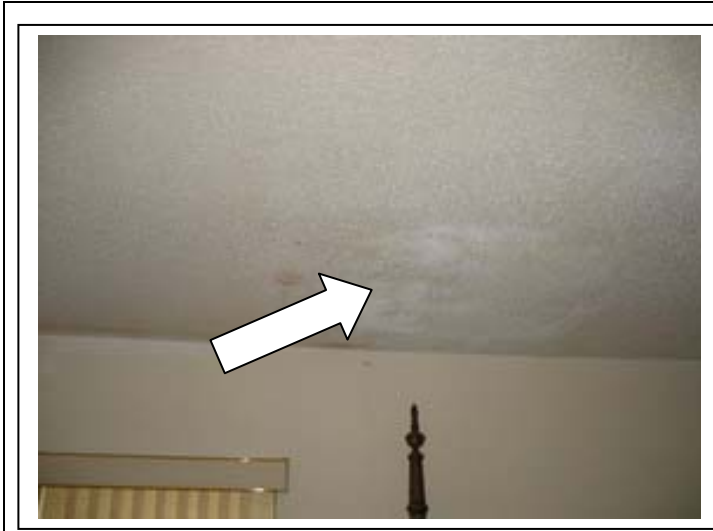
3. The cause of the roof leaks in the bedroom ceiling and bedroom closet ceiling appears to be from gaps in flashing under the gable end of the roof.

Photo # 10
Stain in bedroom ceiling.

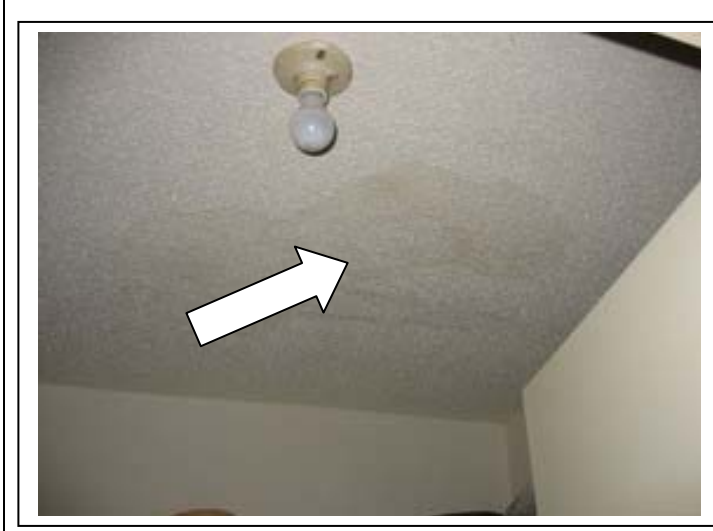
Photo # 11
Stain in bedroom closet ceiling.

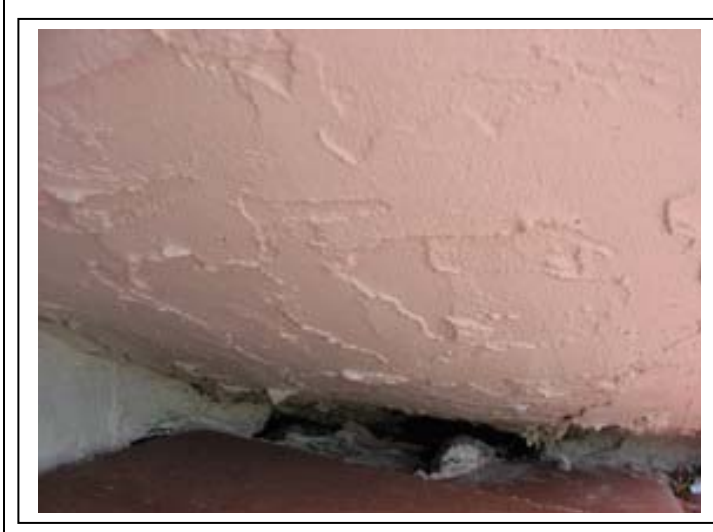
- There may be gaps in the flashing under the eave of the gables over the garage and master bedroom. Normally the pitch of the roof and the depth of the eave at these points should keep water from penetrating small openings under these eaves. The hurricane force winds may have widened or created gaps in the flashing under these eaves and driven water through the gaps. The points under the eaves in the gable on the east end of the home align with the water stains in the ceilings in the bedroom area.

Photo # 12
Possible entry point under eaves for water to damage ceiling in bedroom area.

The stains were dry at the time of this inspection; however the owner stated that rains after hurricane Wilma have widened the stains. The gaps can be filled temporarily with expanding foam sealant. There may also be some other entry point in this area of the roof. There are damaged and missing tiles in this area and the water proofing membranes may be breached as well. This section of the attic space is inaccessible to observe the exact points of the leaks. The roof in this area needs to be cleared of the tiles and inspected by a roofer to determine the necessary repairs.

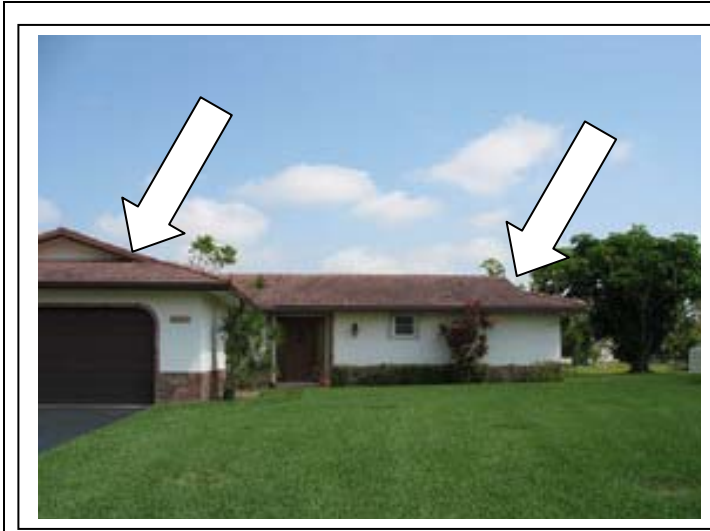
Photo # 13

Eaves under gable ends of the roof may have flashing problems.

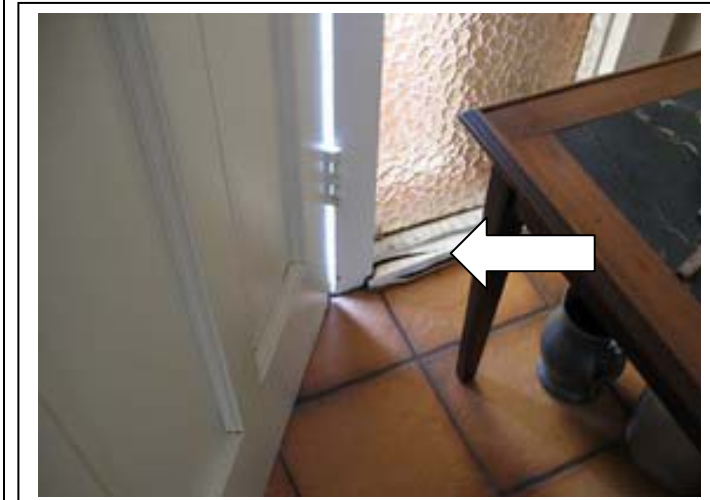
Photo # 14

Wood rot near entry door needs to be repaired.
